**Department of Workforce  
Services  
Office of Standards and  
Compliance  
Wyoming OSHA**

**Presented by:  
Mike Todd, CRM  
Administrator  
Wyoming OSHA Division**

## Well Servicing Fatality MAY 15<sup>TH</sup> 2013

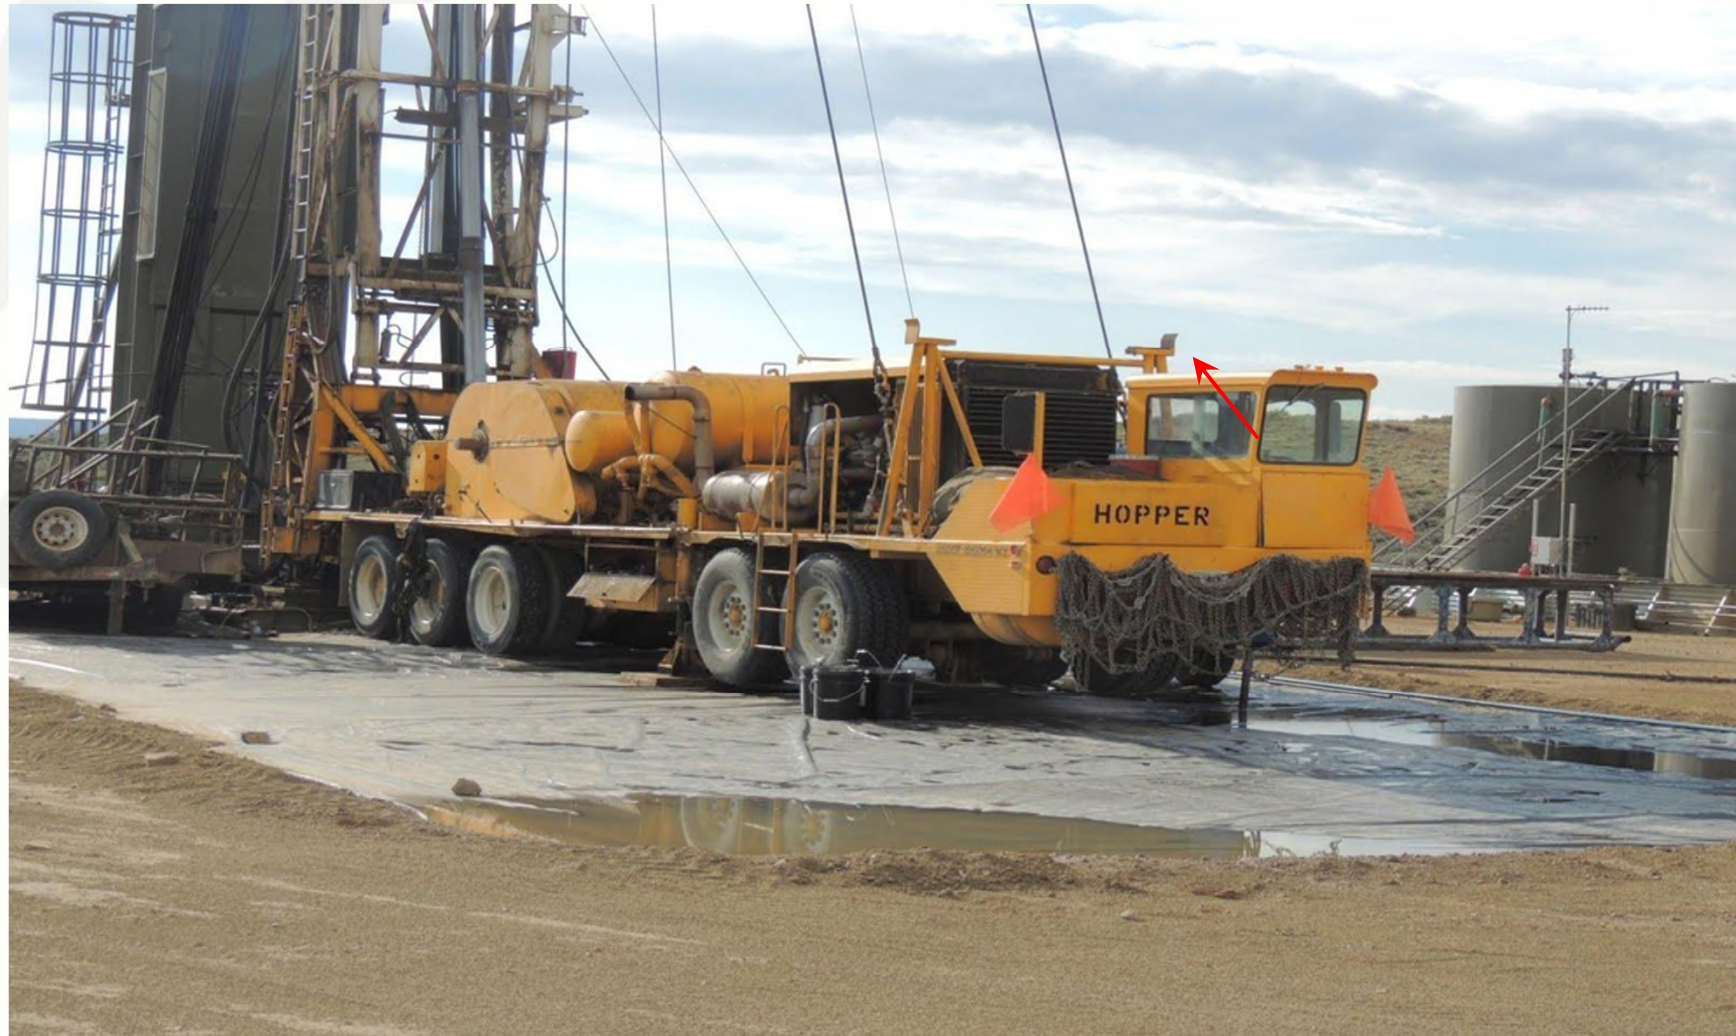
**1981 Hopper Gaxxta, Manufactured in Bakersfield, California. Third owner. Described as designed for shallow to medium depth well.**

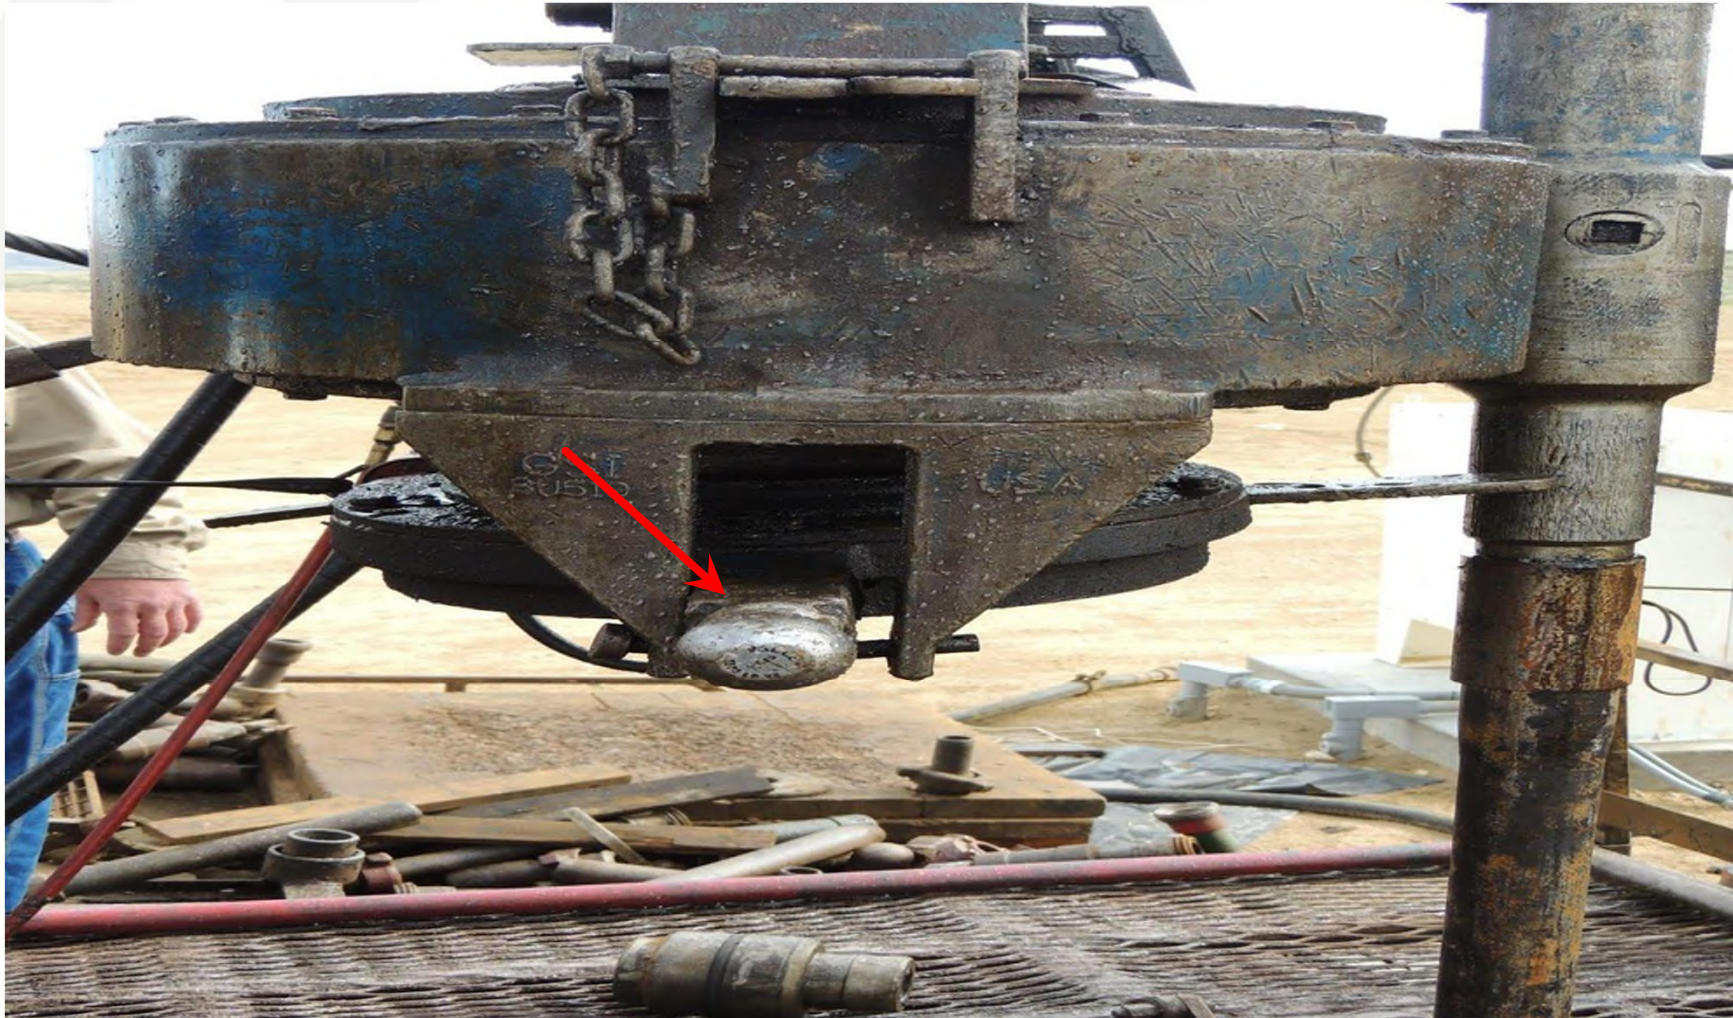
**Foster type, slip over tong system, with modified trailer hitch ball welded on tong end (red arrow), used to flip tongs.**

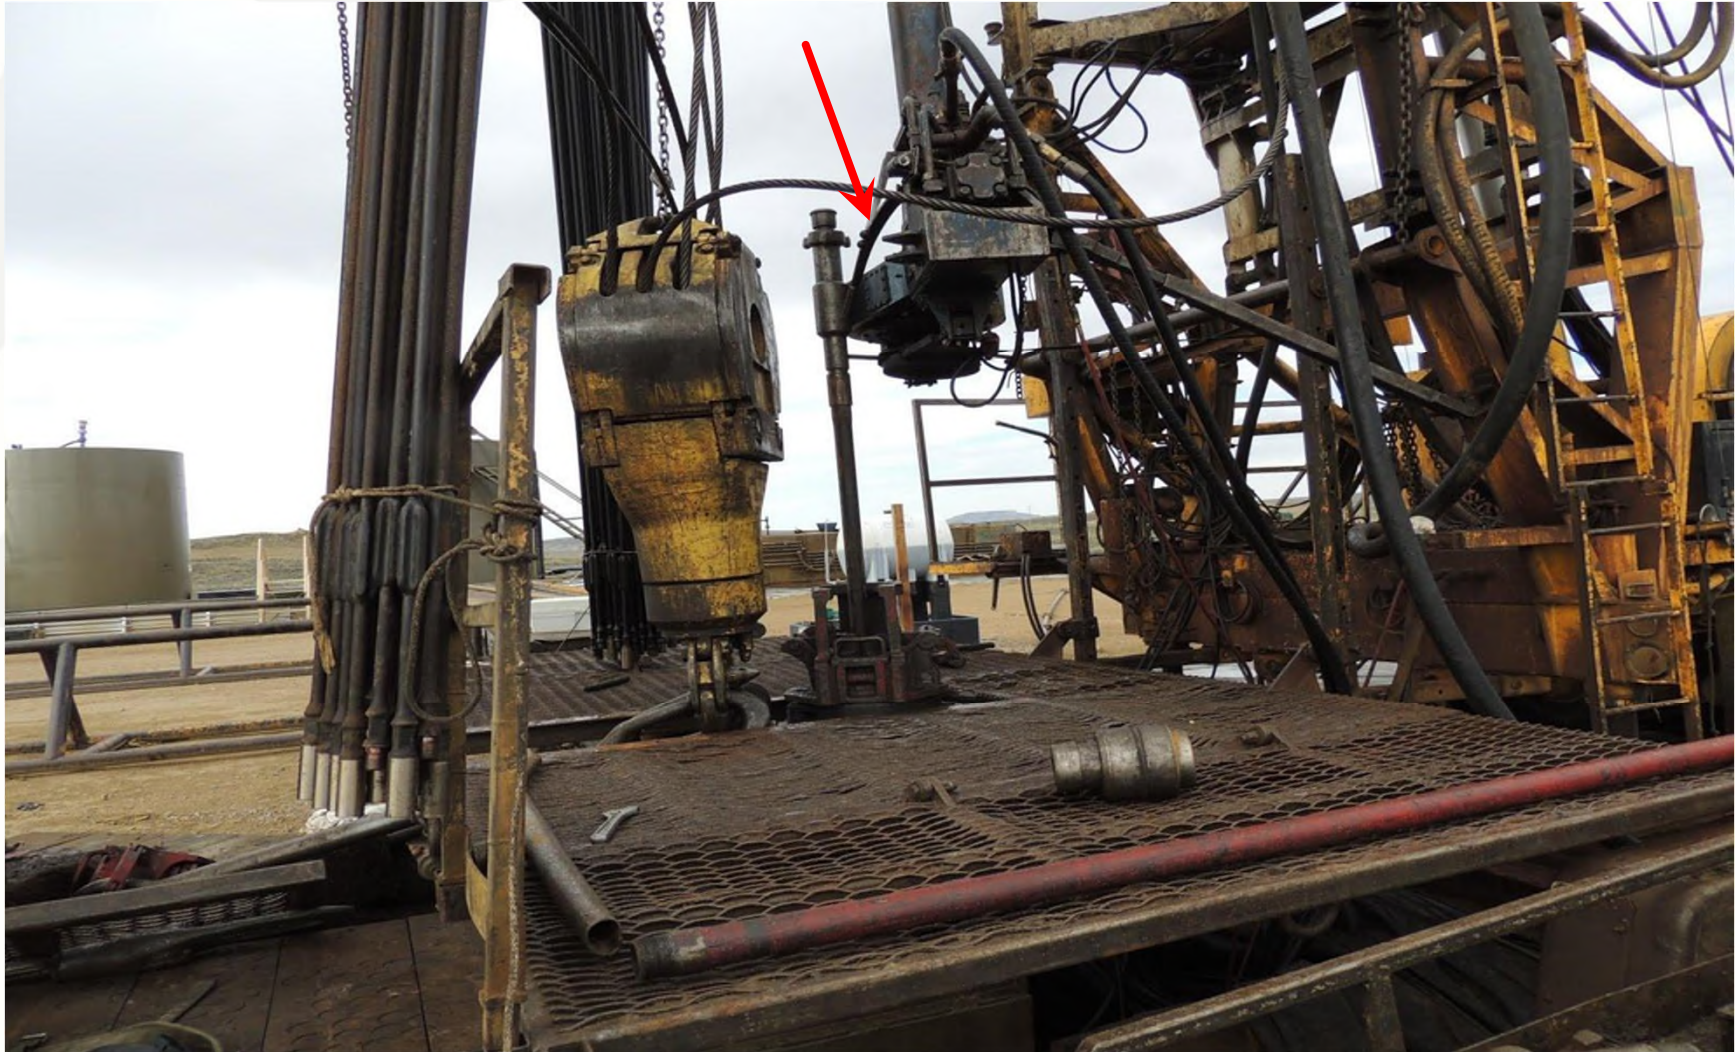
**Foster style tong with bent handle.**

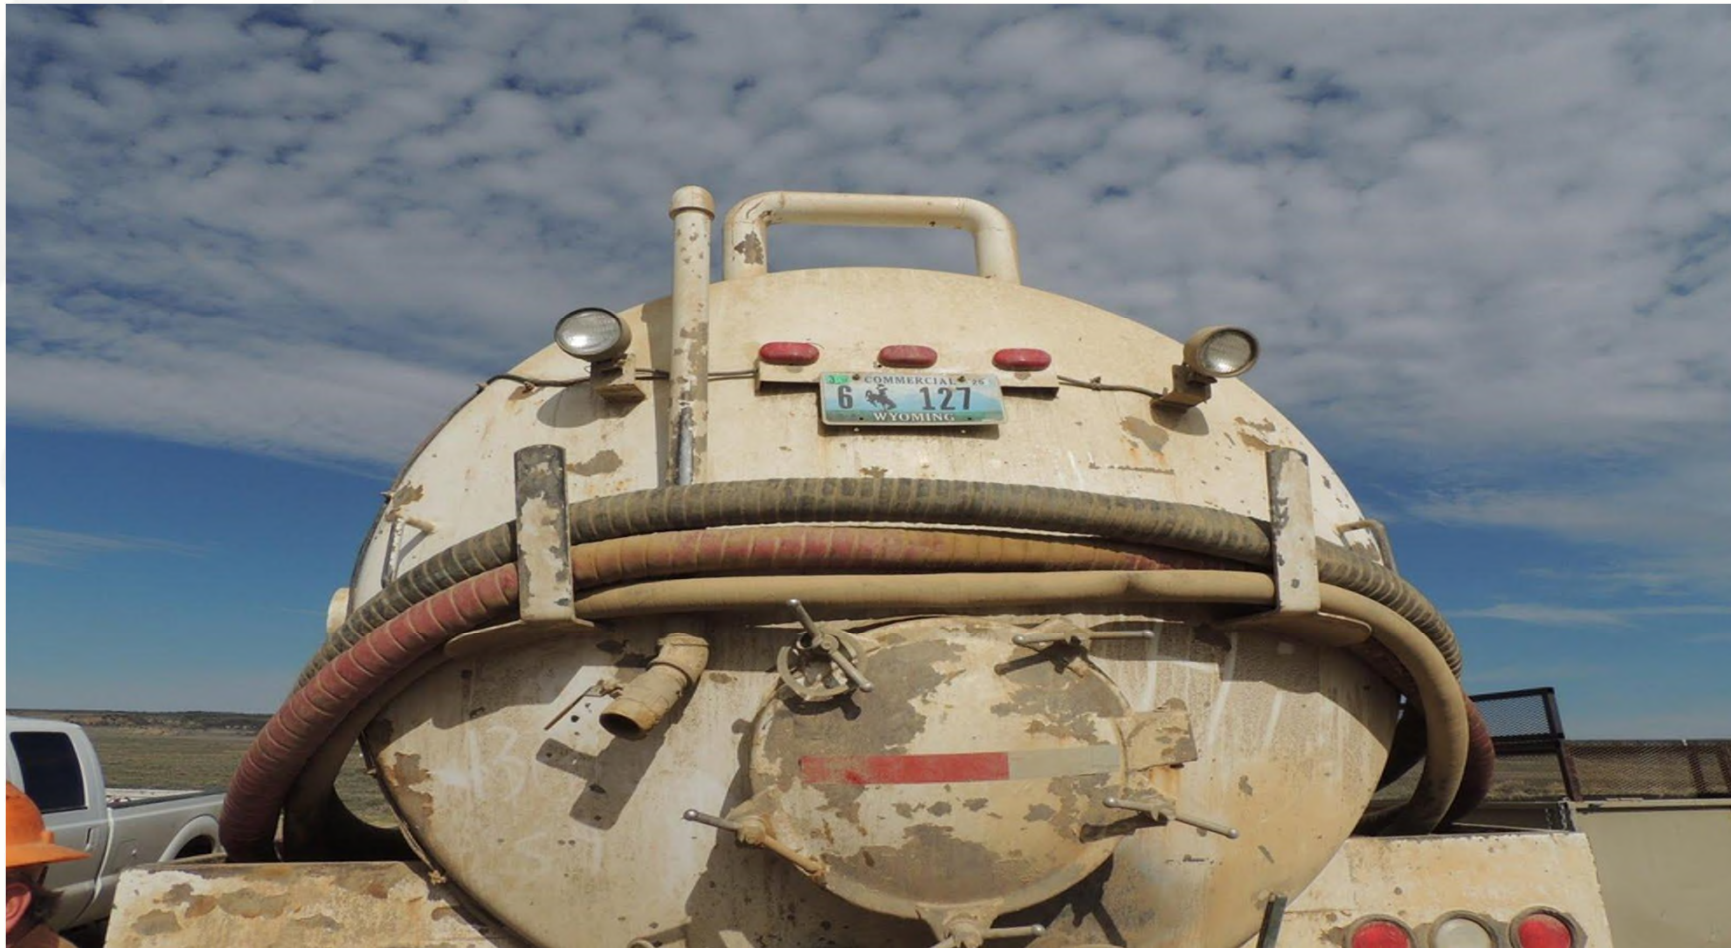
**Back of pump truck on site to suction fluid from well cellar. Driver was positioned here when blocks fell. Driver yelled as he heard load whine, then dove under truck.**

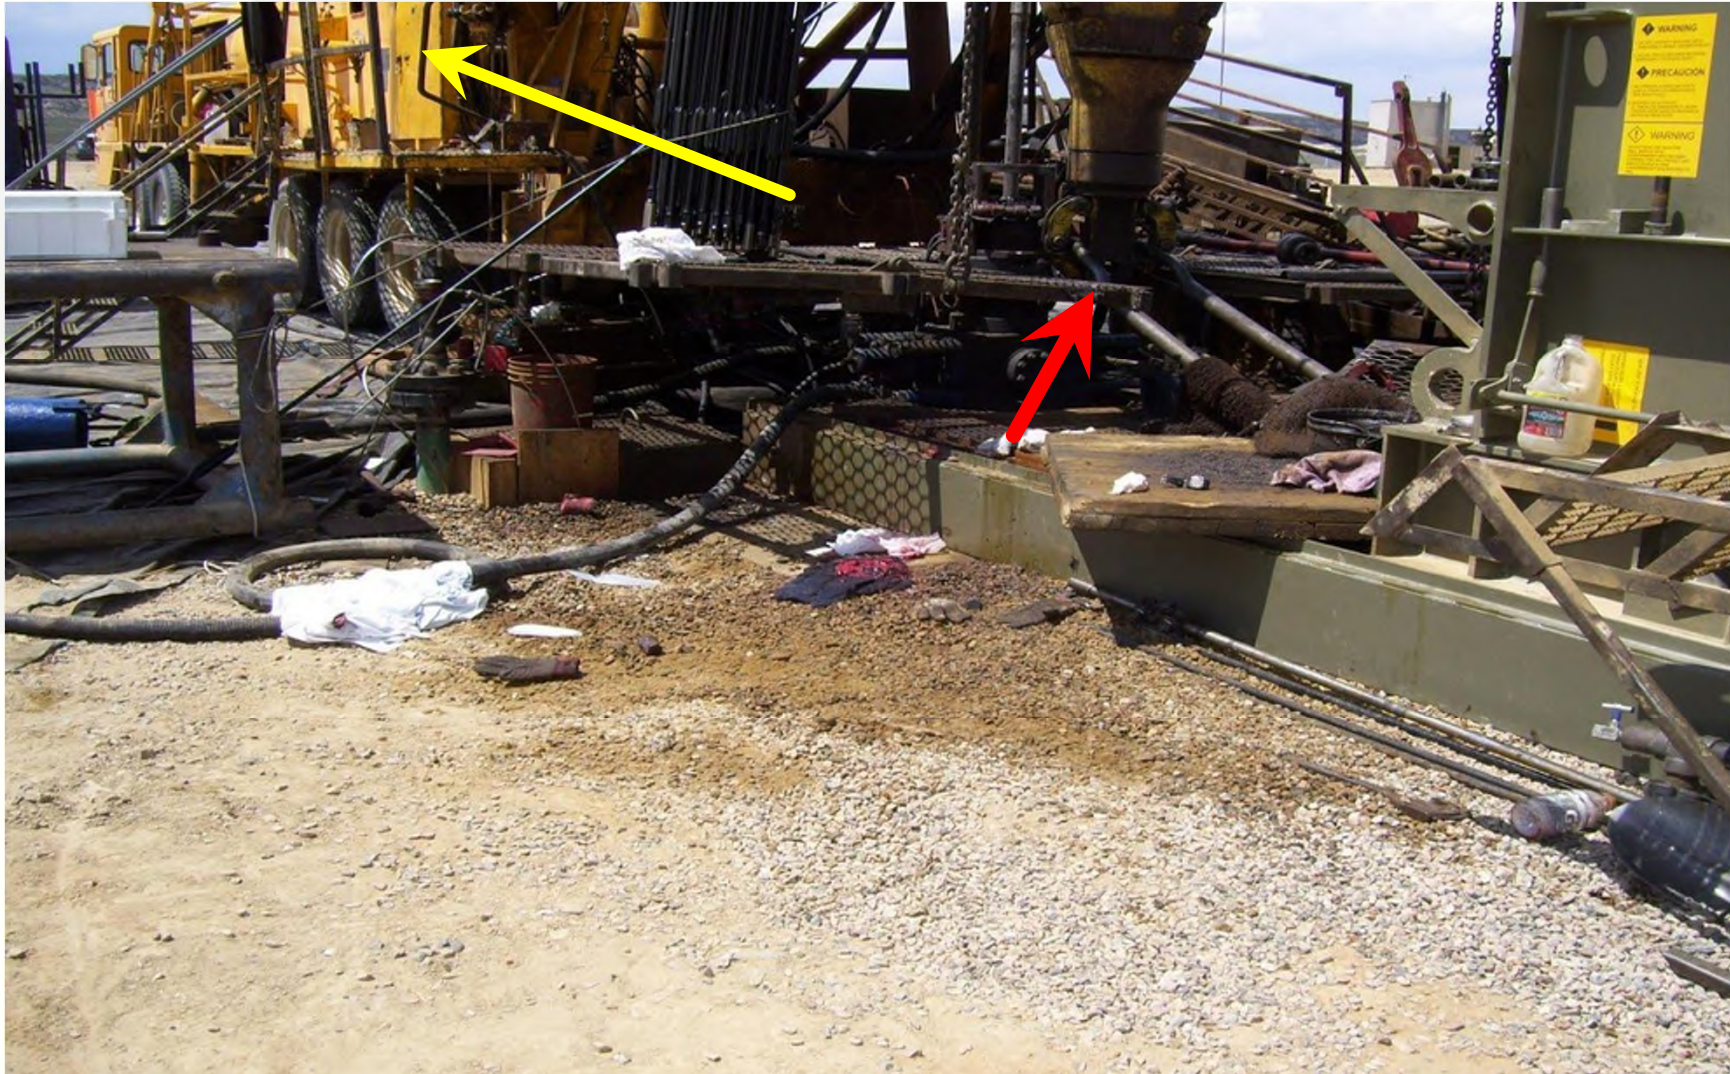
Deceased position (red arrow). Brake handle location (yellow arrow).

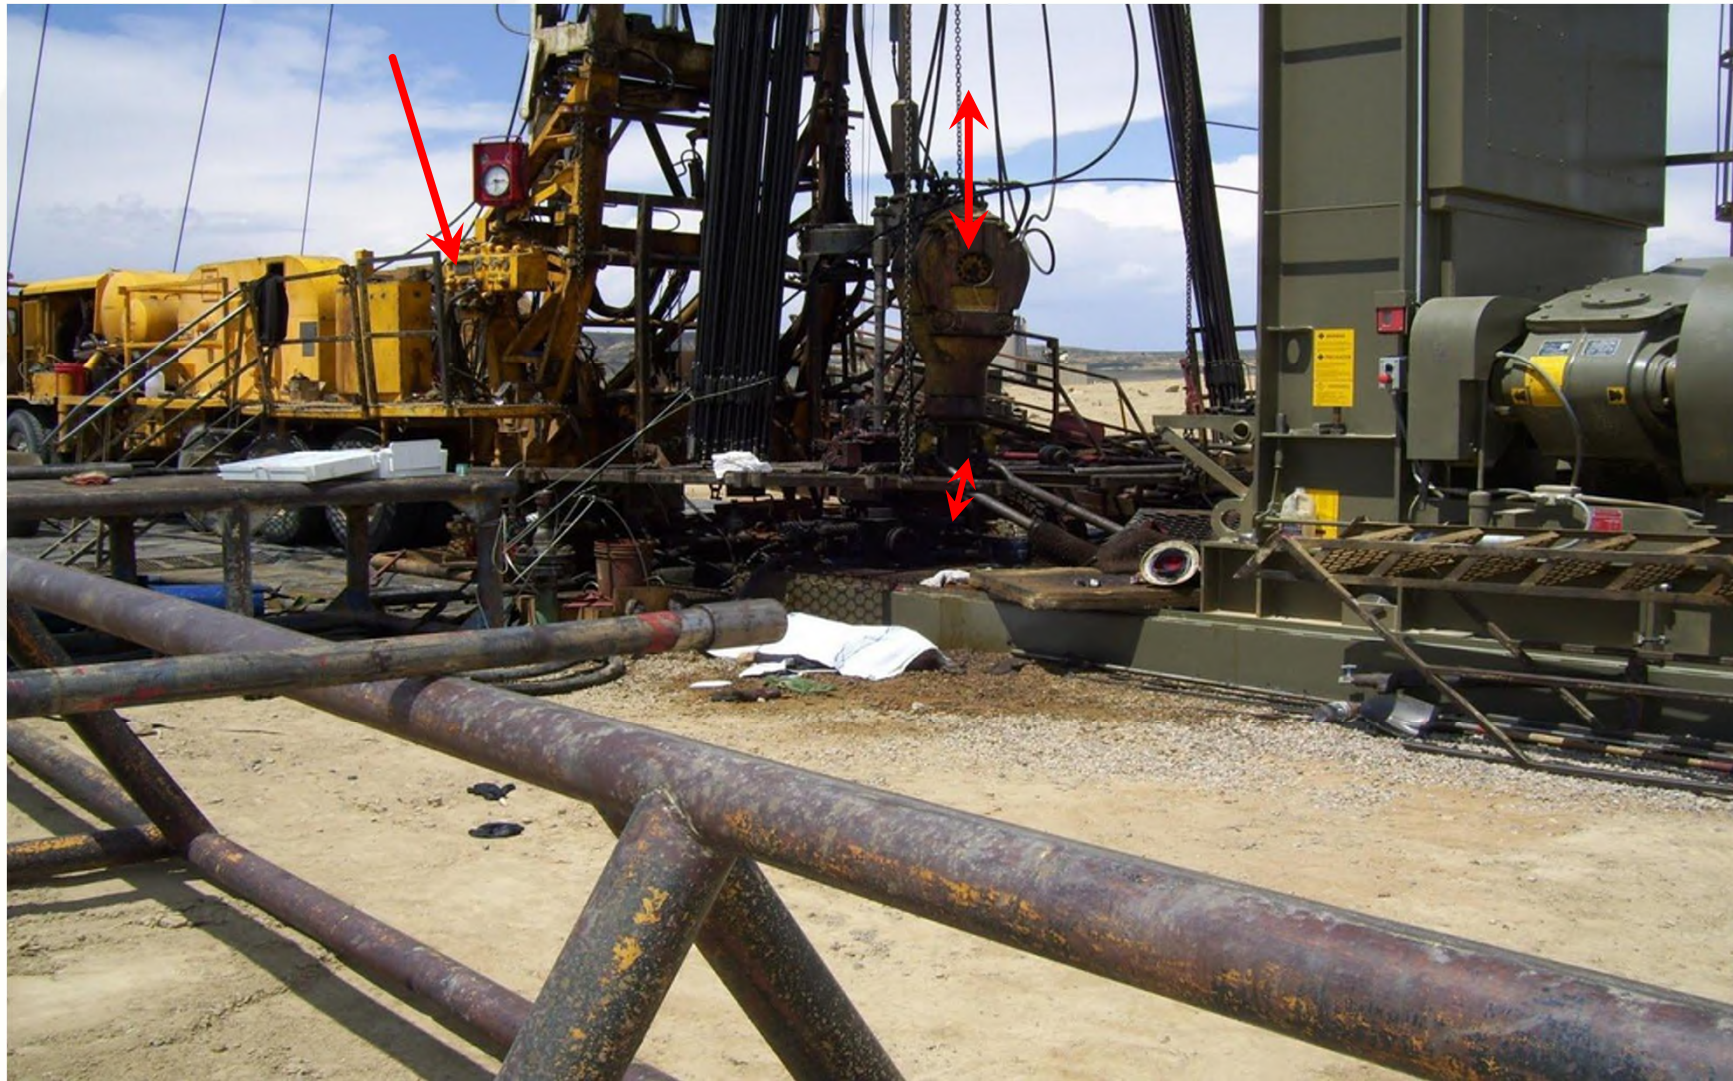
**Traveling blocks suspended by tuggger winch.**

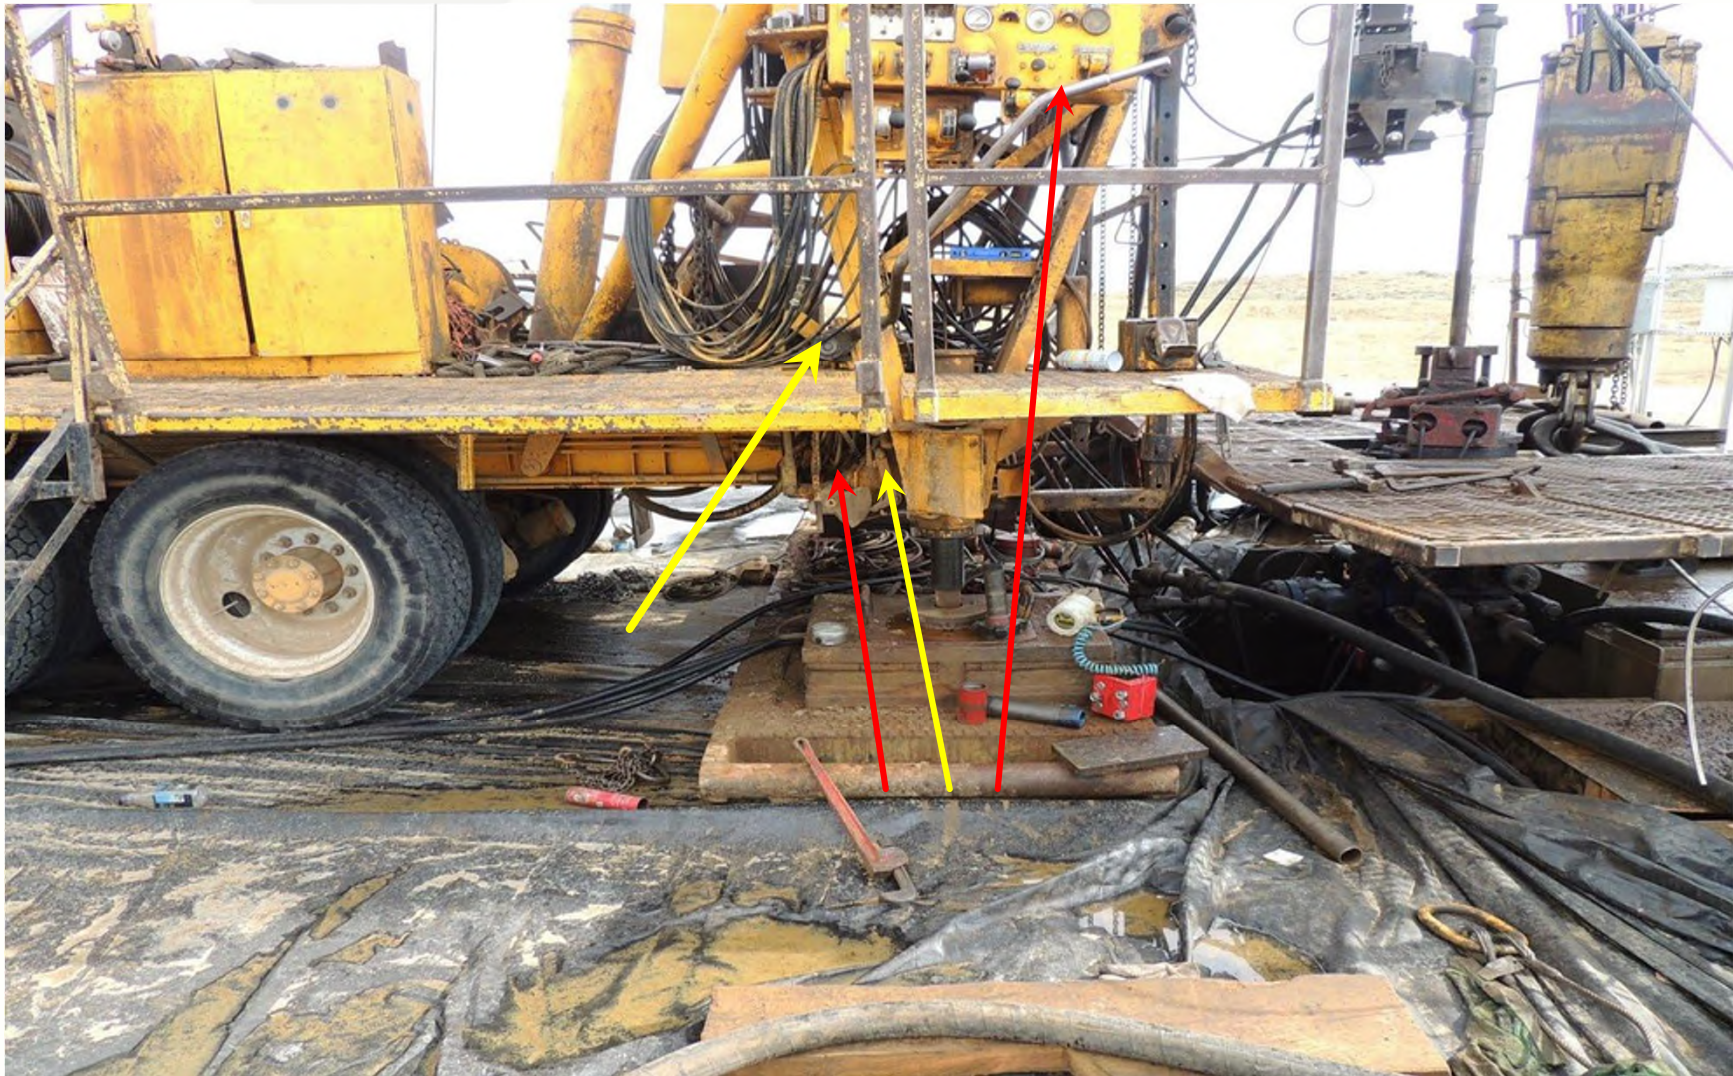
**Operator station, brake handle (red arrow), linkage, lock mechanism (yellow arrow).**

- Operator left his post at the operator's station leaving brake lever unattended, with prior knowledge that the brake system would "creep" if under load as hot brakes cooled.
- Operator broke routine allowing inexperienced victim under suspended load while still tripping tubing in.
- Operator and Owner failed to conduct near miss investigation and provide corrective action on equipment after near miss in early 2013.
- **Incident was predictable and preventable.**

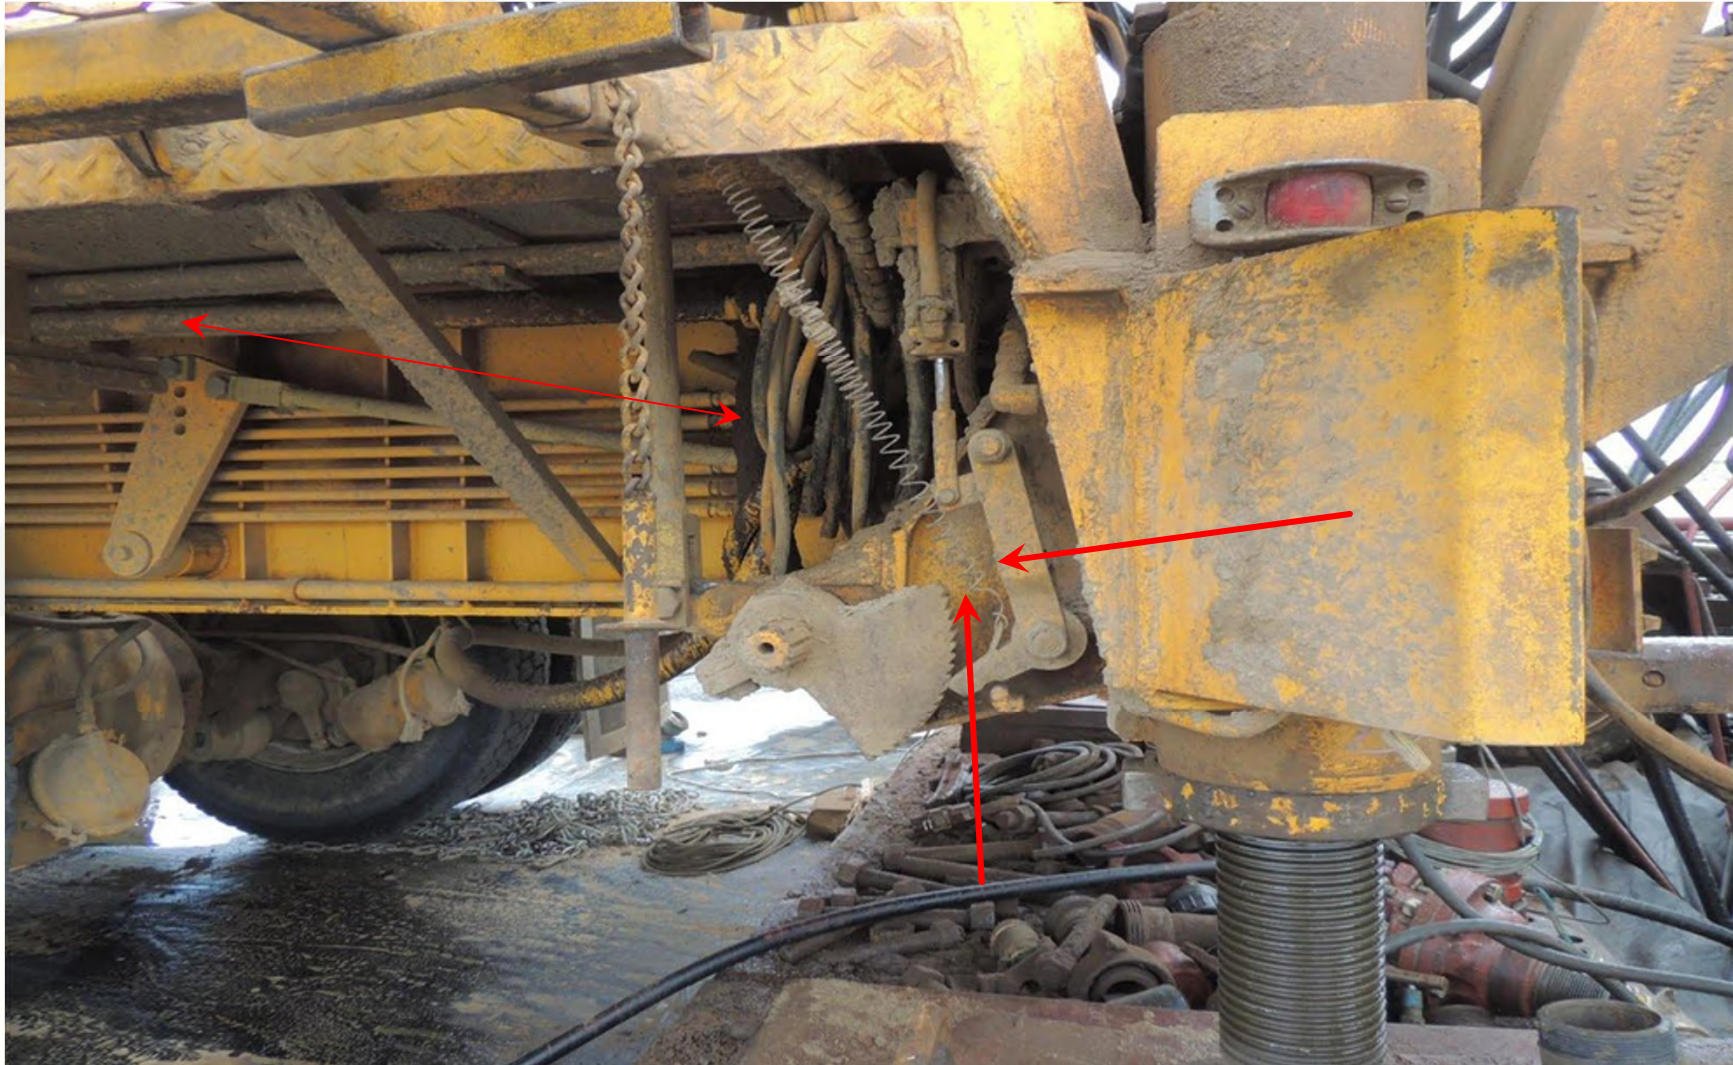
Brake linkage lock assembly with spring below operators station.

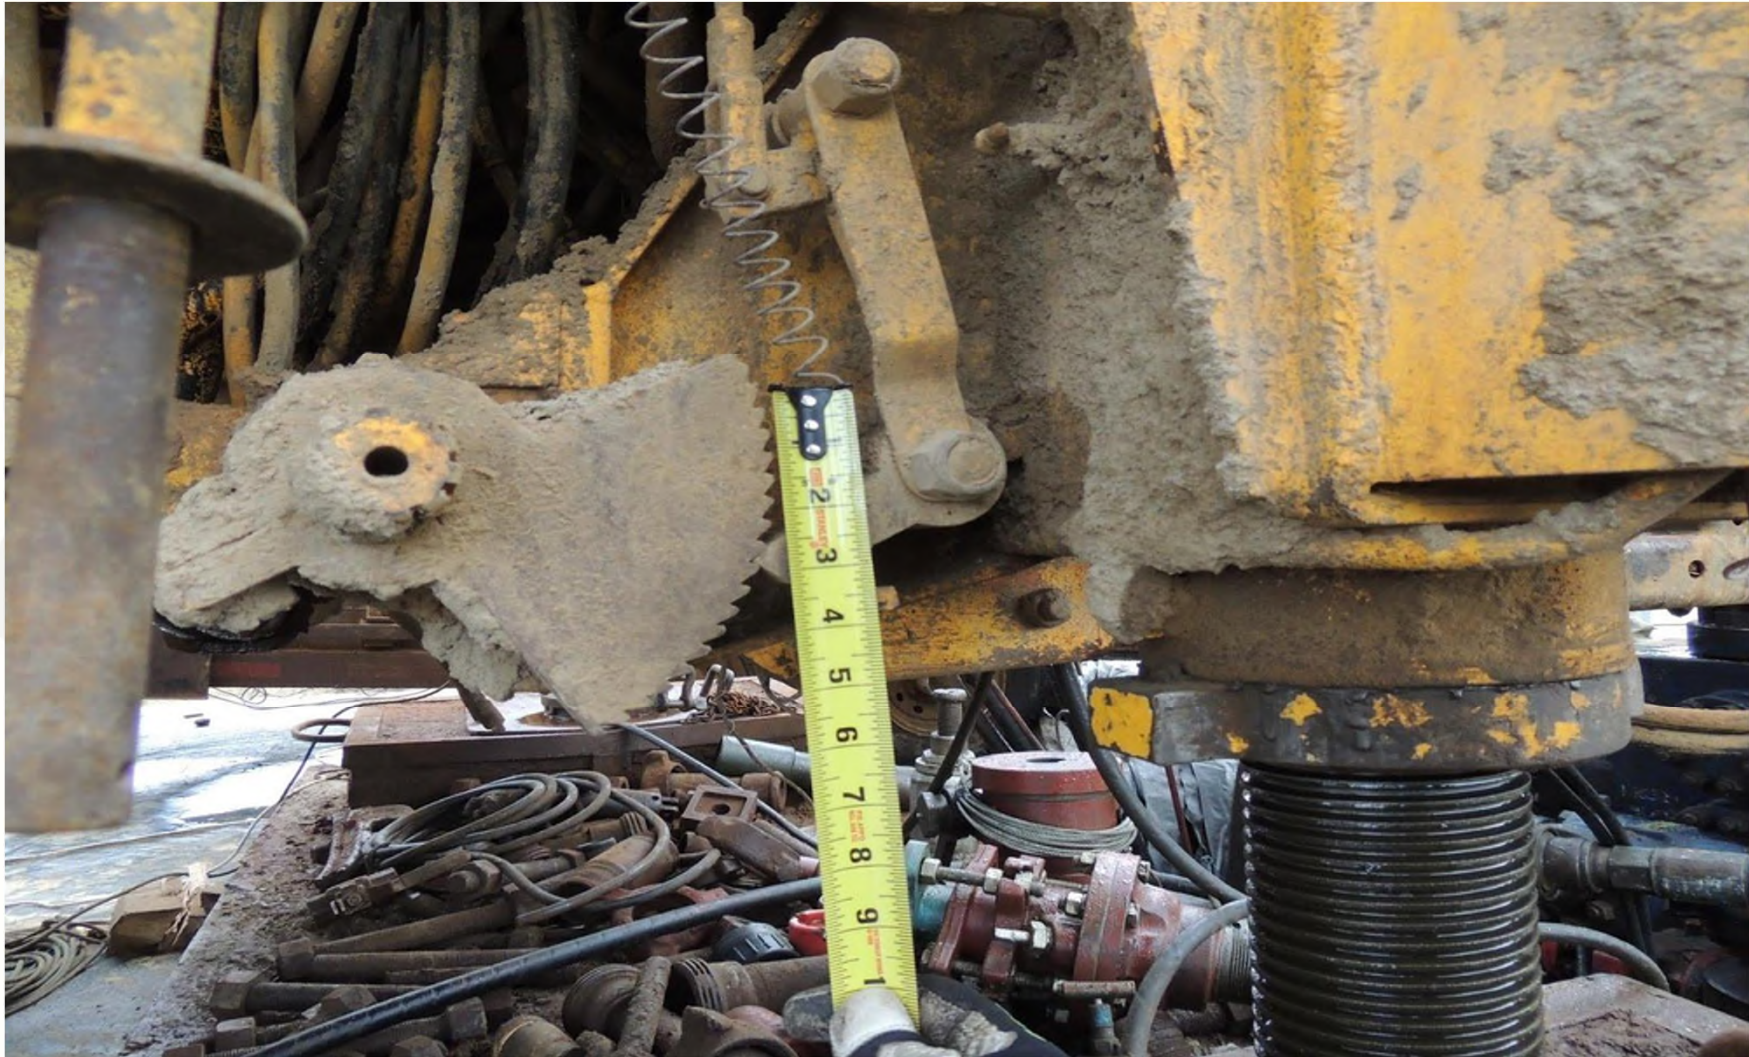
**Draw works locking mechanism below operators deck.**

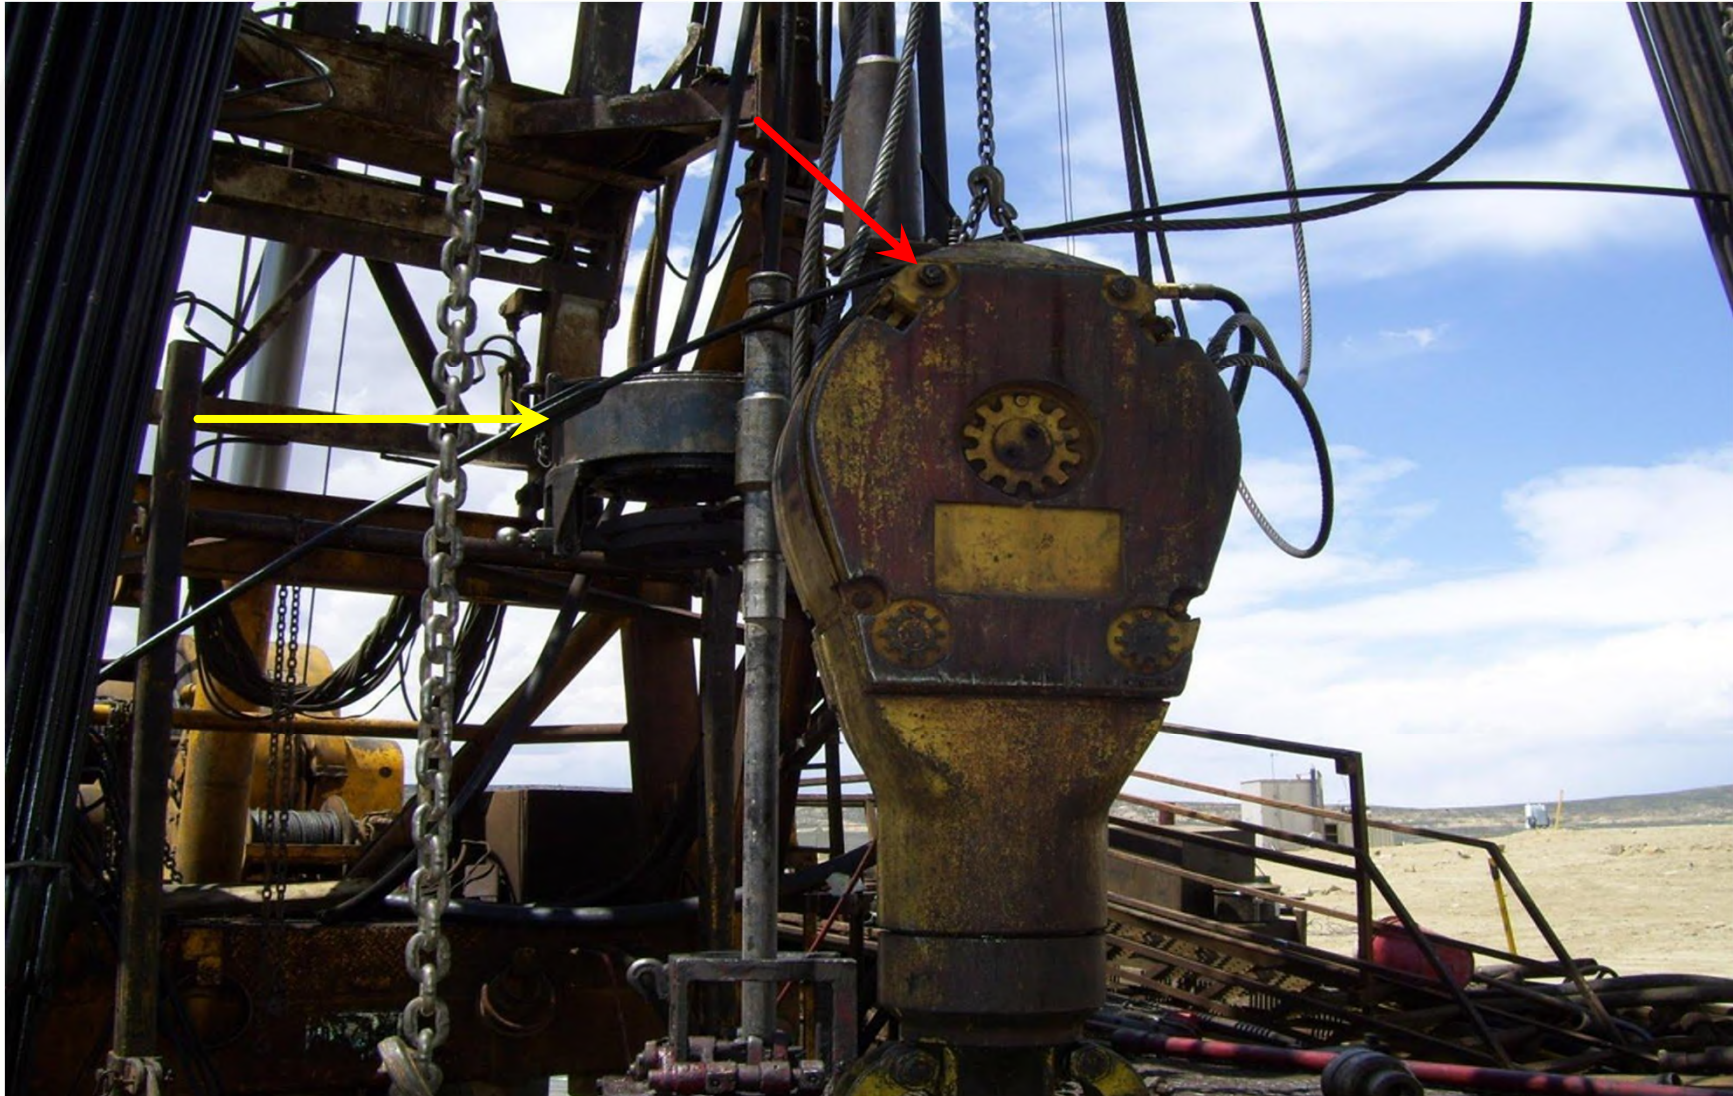
**Chain attached to blocks (red arrow) with tongs (yellow arrow) in background.**

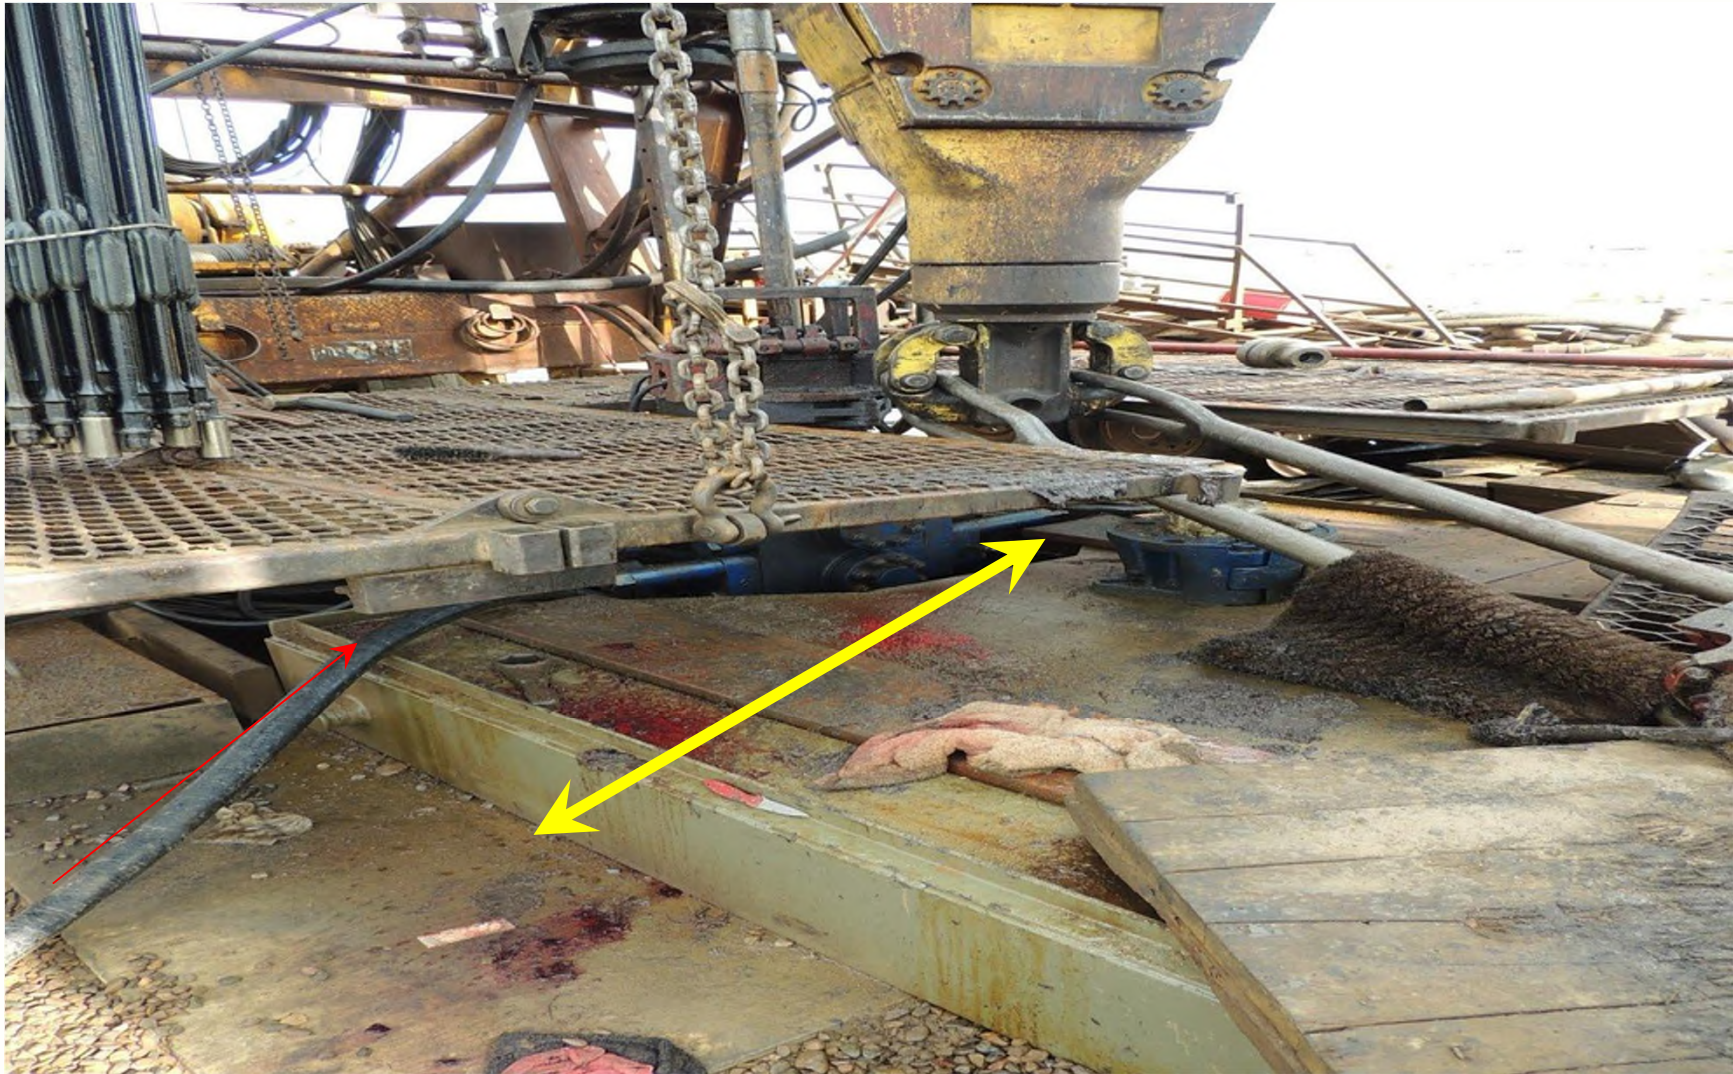
**Suction hose to left of victim location at time of impact.**

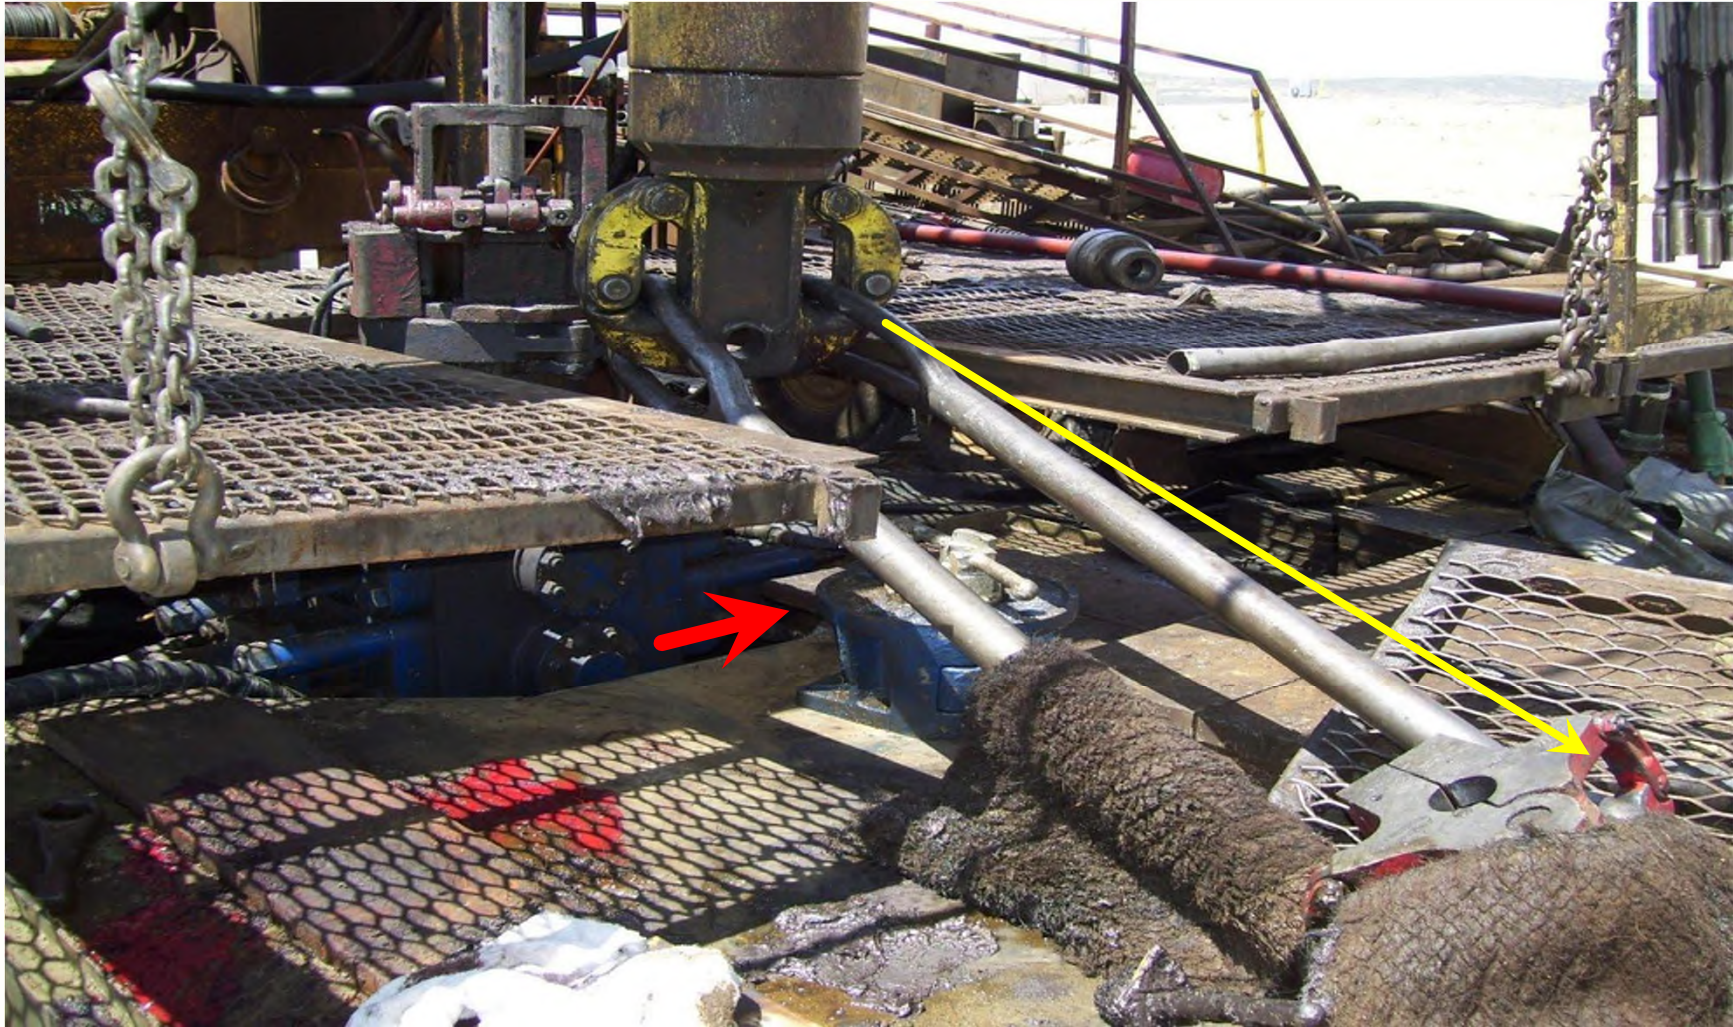
**Arrow (yellow) indicates island board channel & island, pushed out by bails. Arrow (red) indicates deceased approximate position at time of impact.**
