**Department of Workforce  
Services  
Office of Standards and  
Compliance  
Wyoming OSHA**

**Presented by:  
Mike Todd, CRM  
Administrator  
Wyoming OSHA Division**

## Well Servicing Fatality MAY 15<sup>TH</sup> 2013

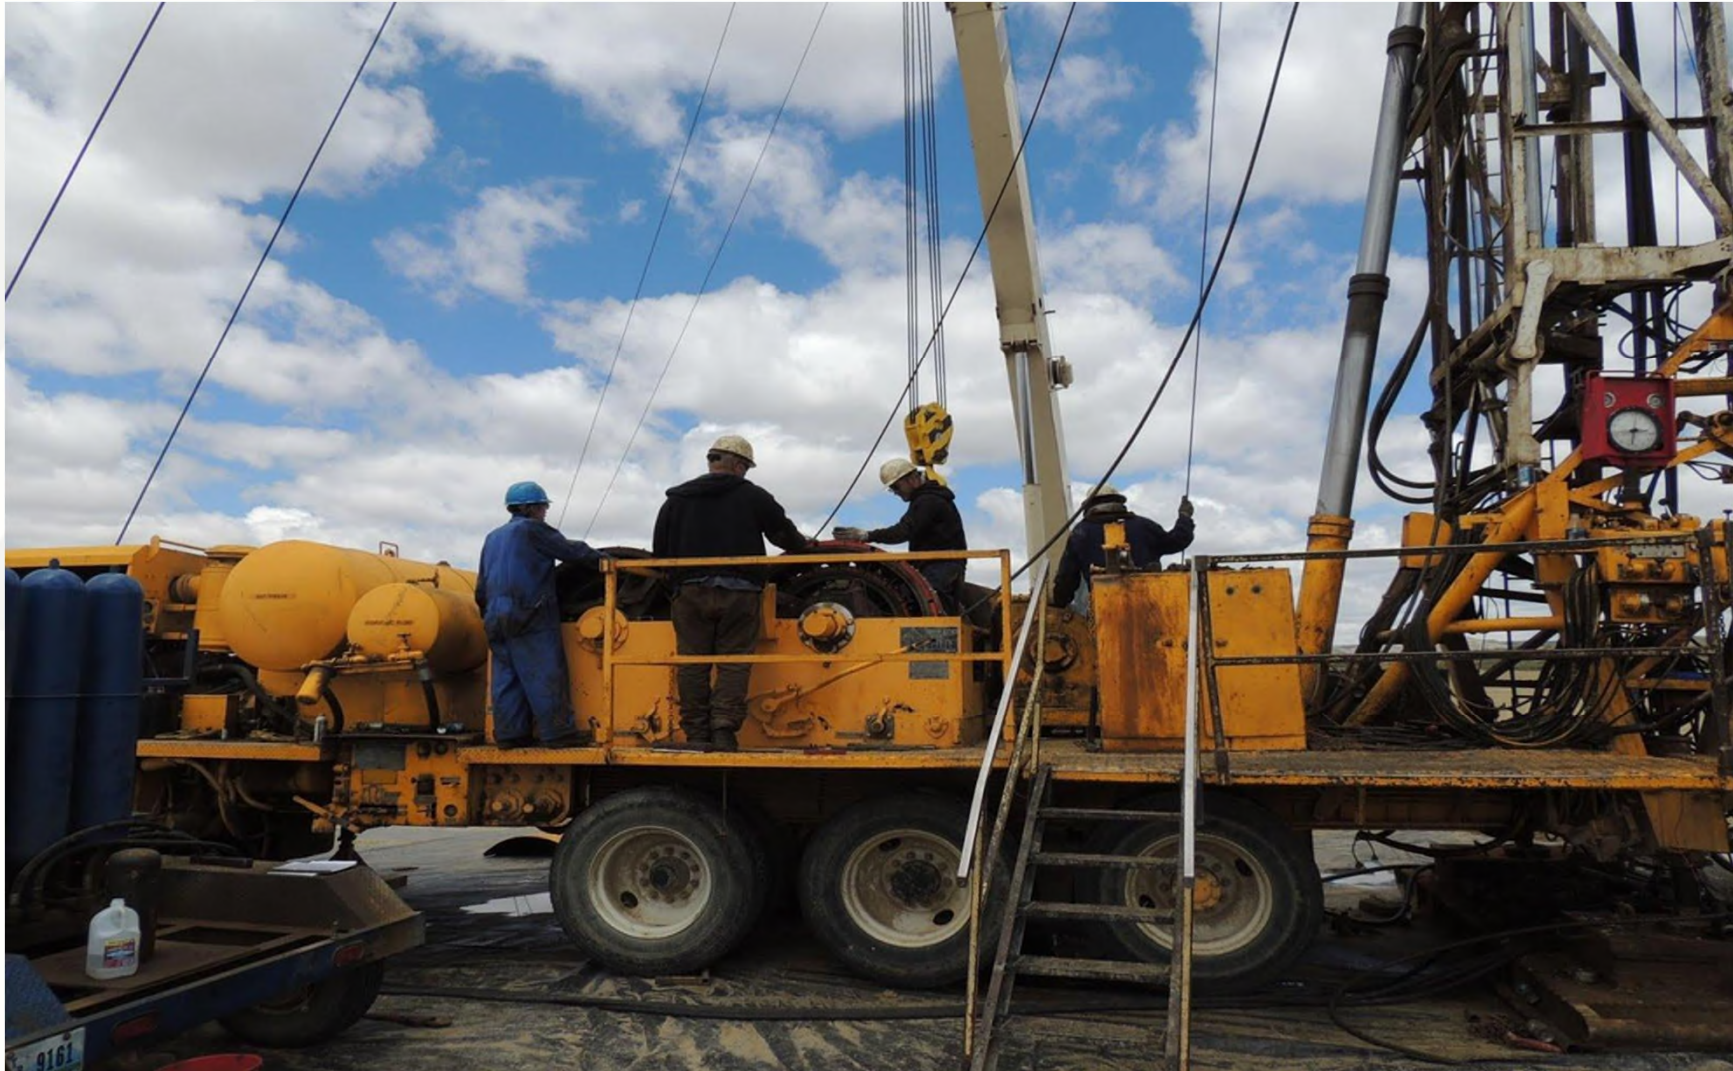
## WY-OSHA observes draw works & brake system investigation.

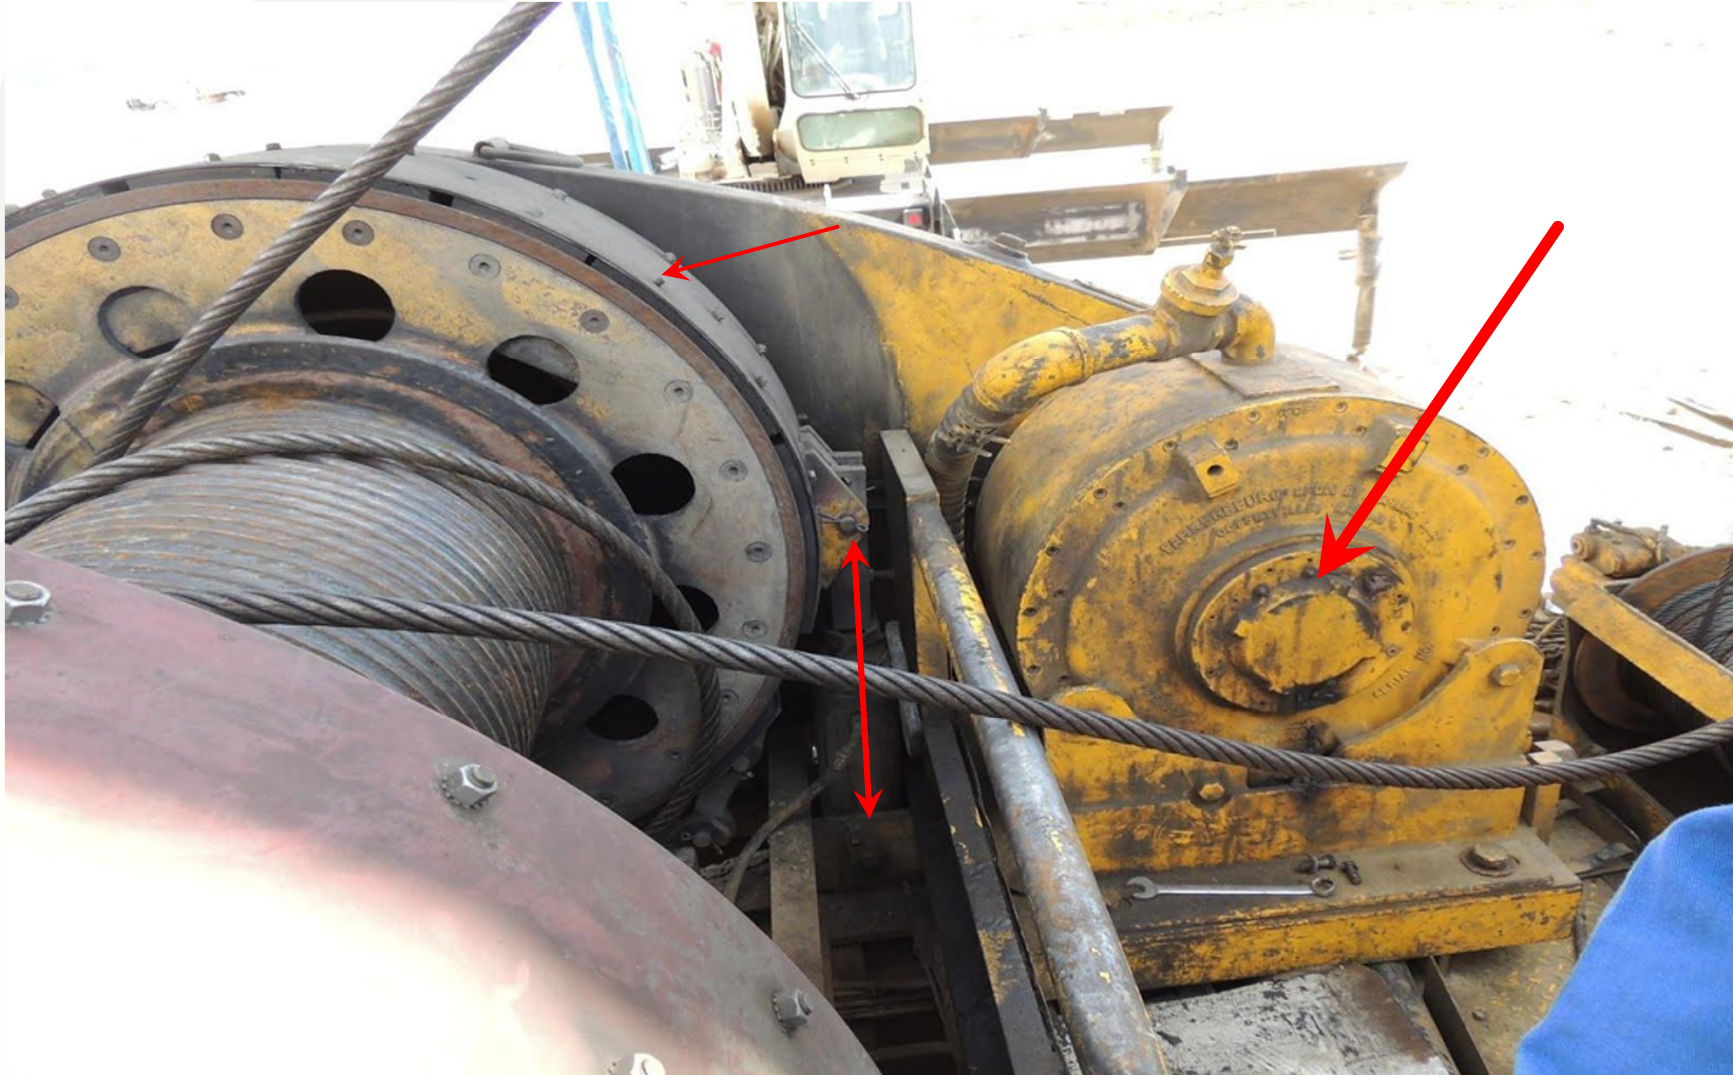
- Brake lever, linkage found to be in serviceable condition.
- Brake bands were not inspected on a routine basis due to draw work guards.
- Service rig, was not maintained in accordance with manufacturers guide as the company did not have such manuals.
- Brake band pads were within factory tolerances however had many missing retainer bolts.
- Island floor deck insert was not secured in place.

**Draw works, brake bands with missing nut visible (over 17 missing). Front hydro tarter.**

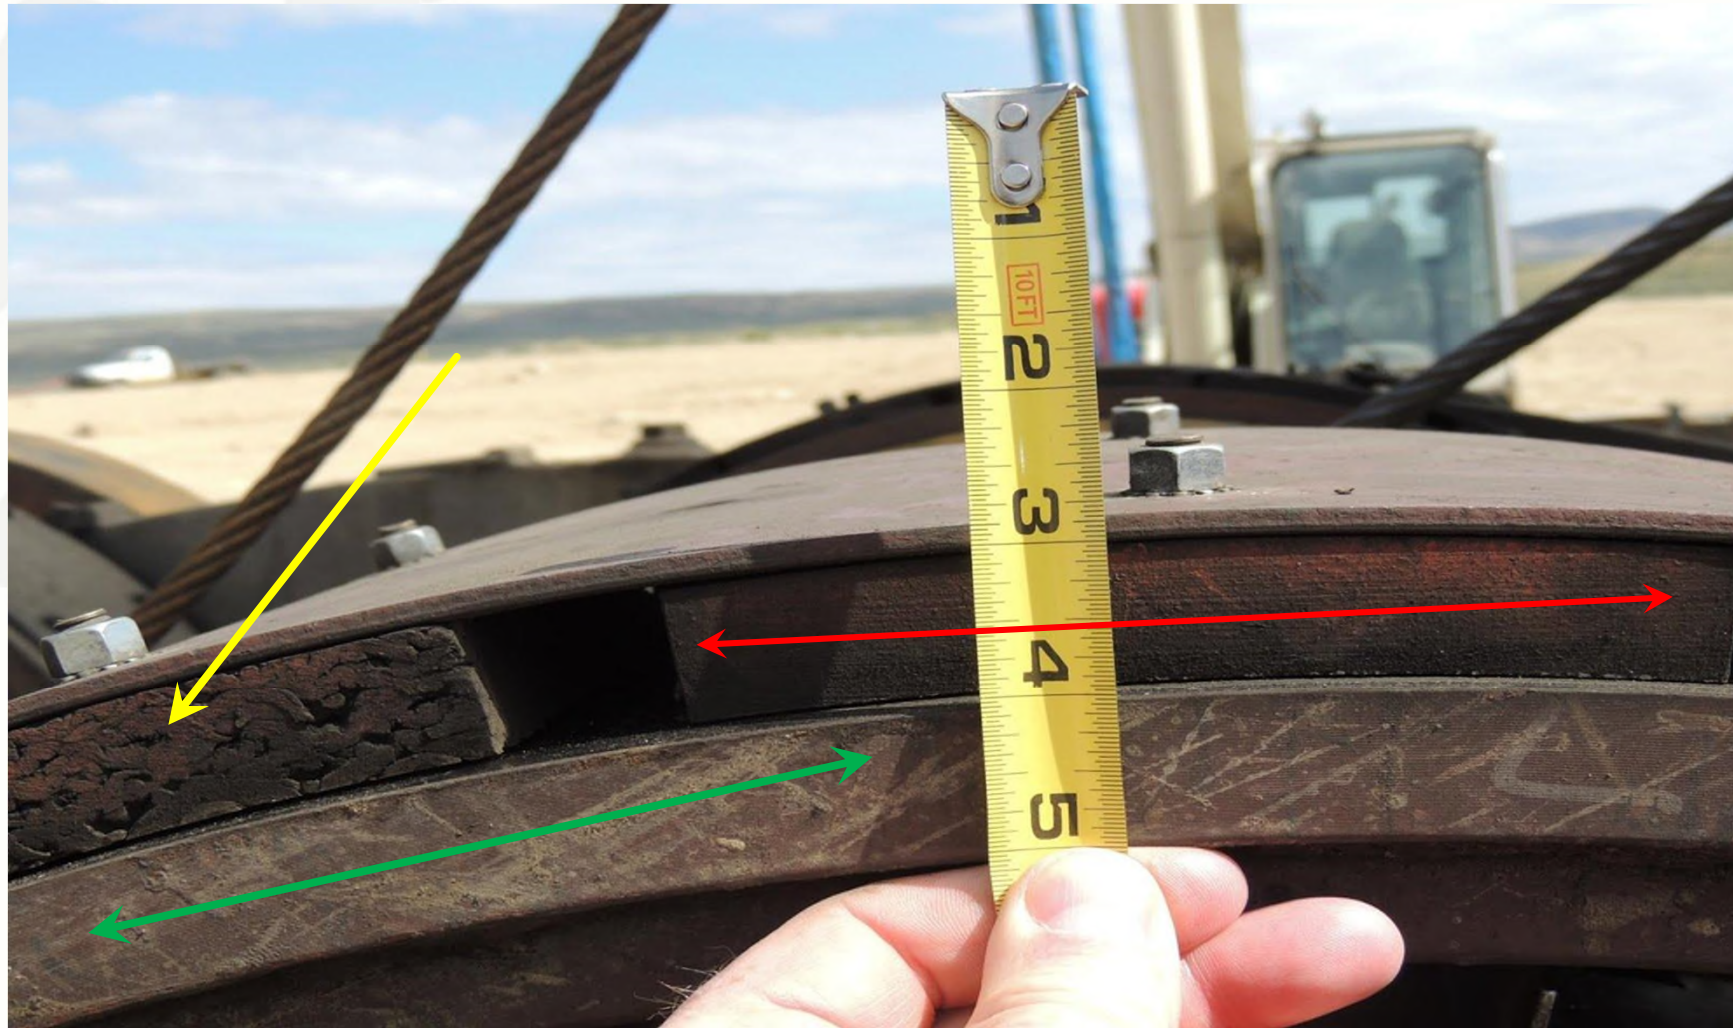
**Old brake bands, 1" Plus. Note hard pads (RED) and soft pads (YELLOW). Drum (GREEN).**

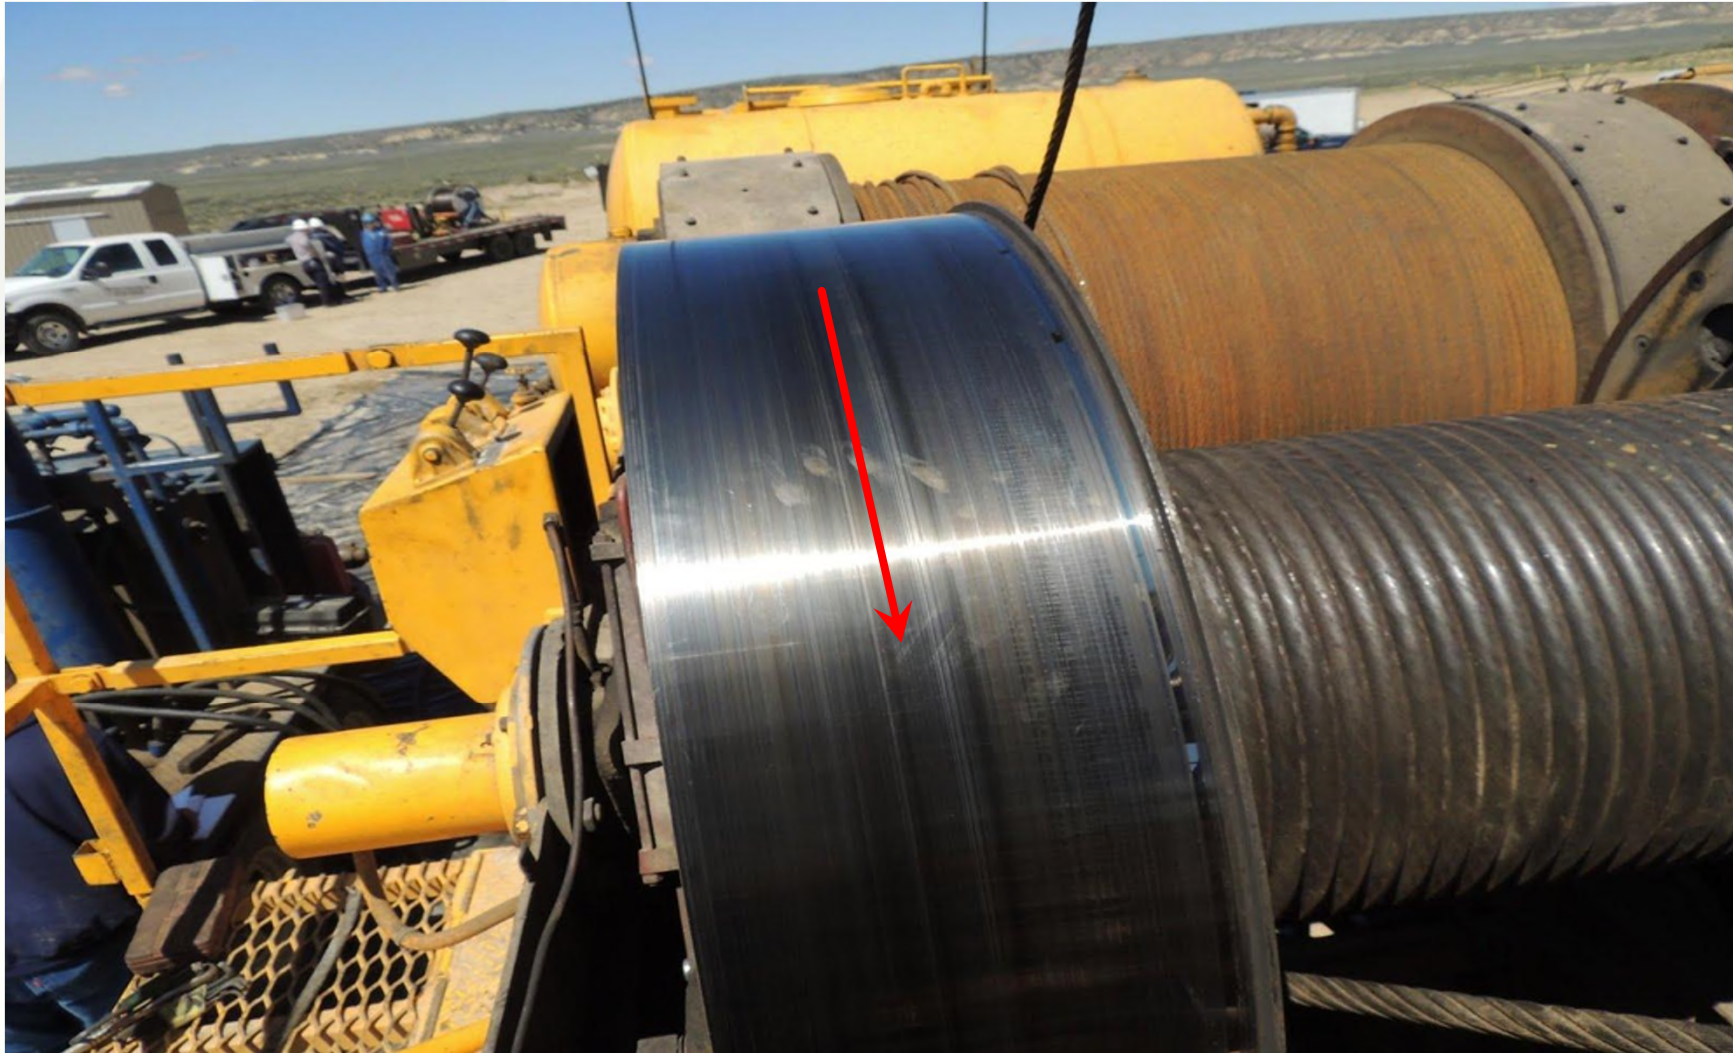
**Draw works, operators side with brake band off.**
