ST. VRAIN CREEK RESTORATION ASSESSMENT

4652 Ute Highway
Town of Lyons

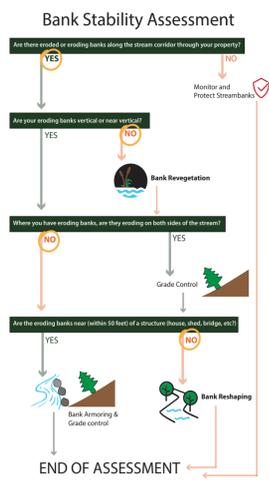
One assessment is seen to the right. Yellow circles designate the chosen path. These assessments identified 12 restoration strategies most suitable for the site, seen below. The information found in the assessments were provided by Left Hand Watershed Center.
