ST. VRAIN CREEK RESTORATION ASSESSMENT

SPRING 2020 MURP CAPSTONE

St. Vrain Creek Restoration Assessment

Prepared for:
Paul Glasgow
Town of Lyons

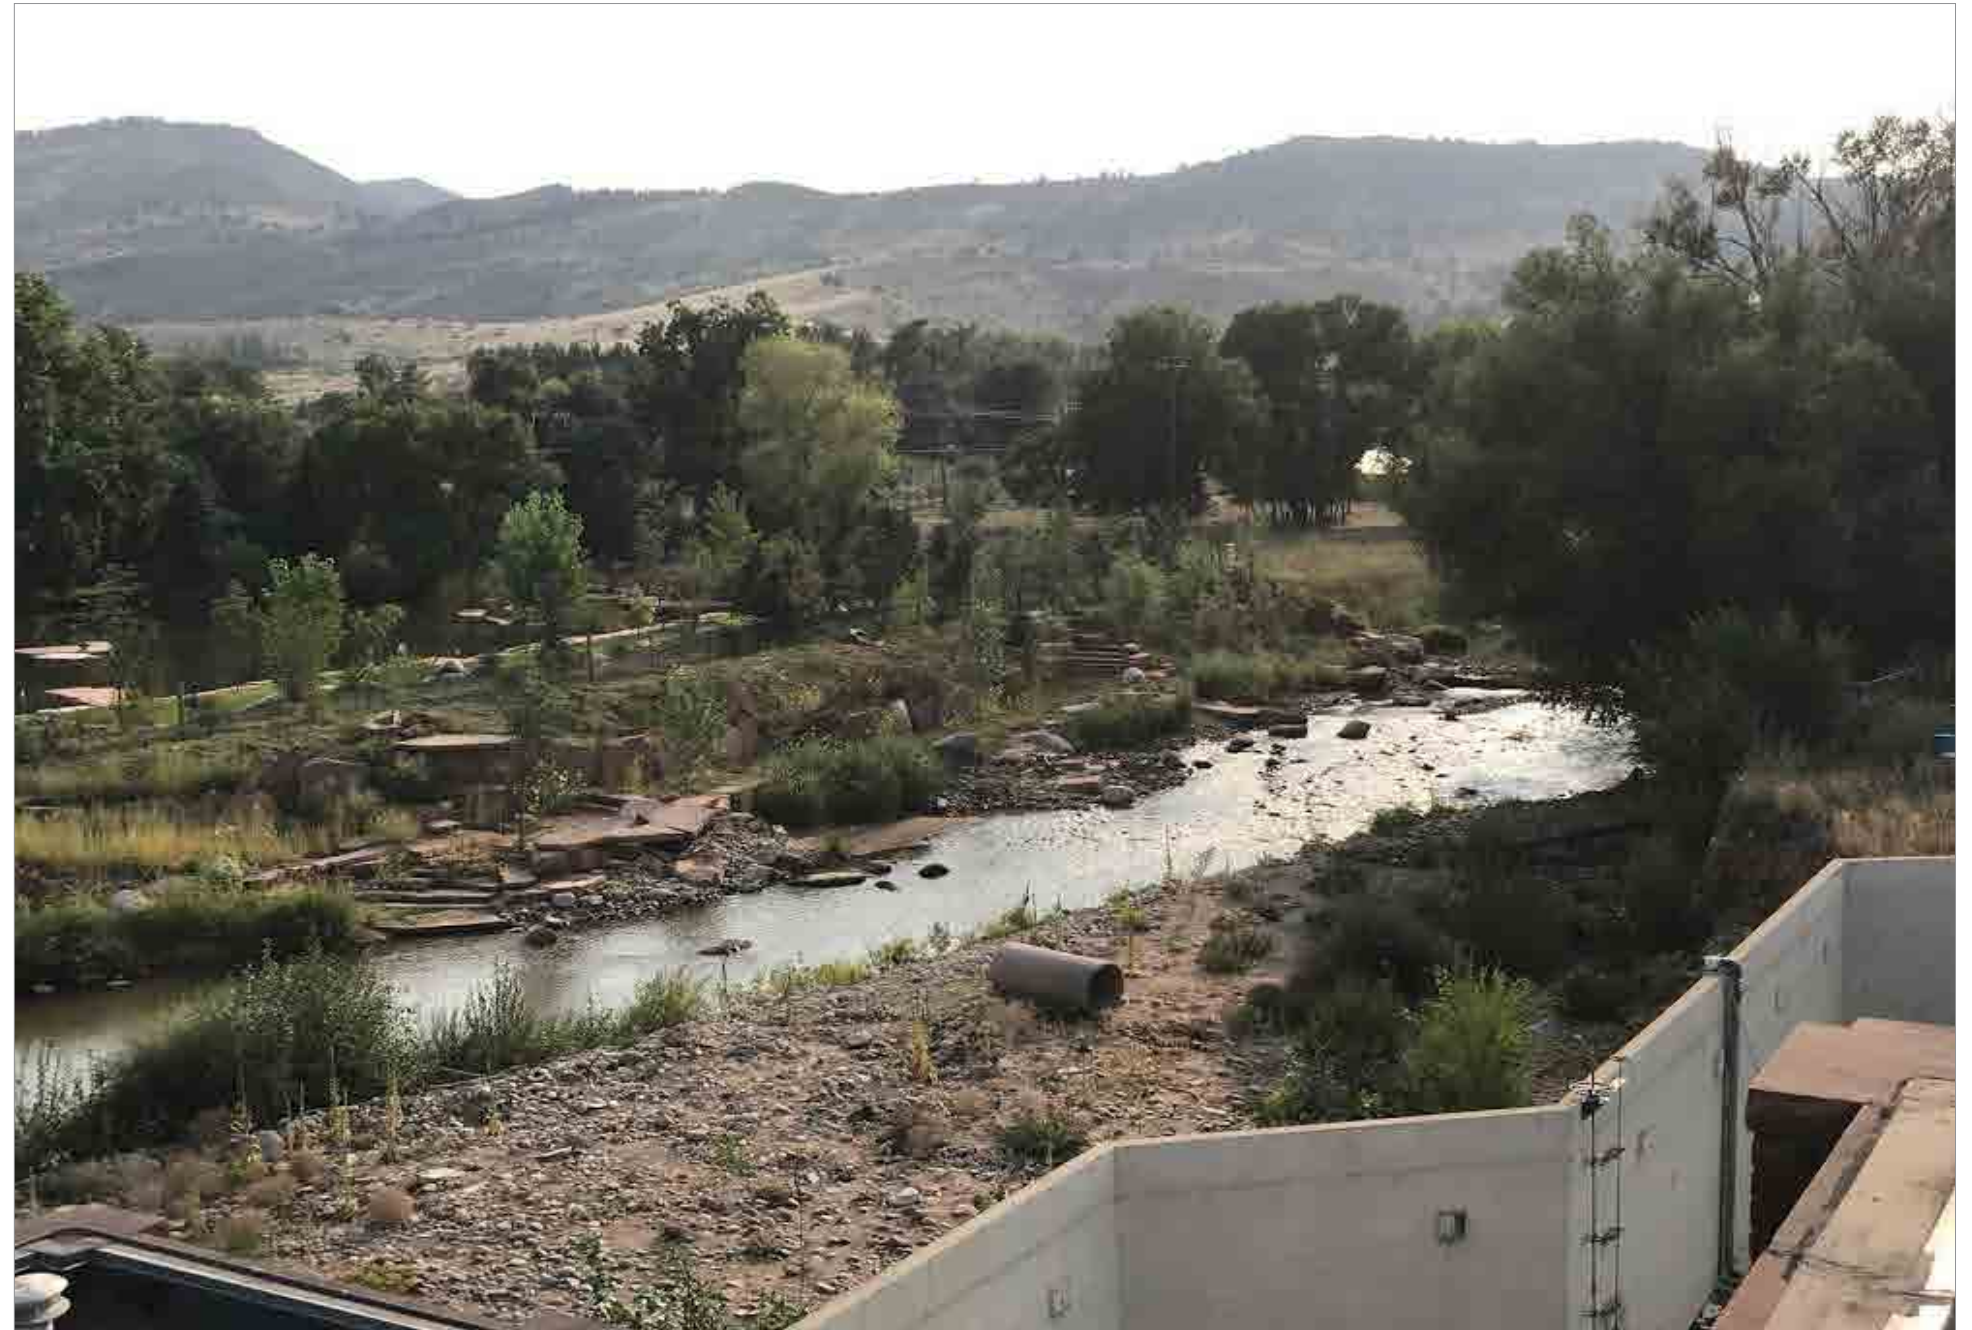
Exhibit 3: A view of the site and its adjacent river reach, looking southwest
