# North Classroom Building Renovation

PROGRAM PLAN *AMENDMENT* | MAY 16, 2014

University of Colorado Denver  
Office of Institutional Planning

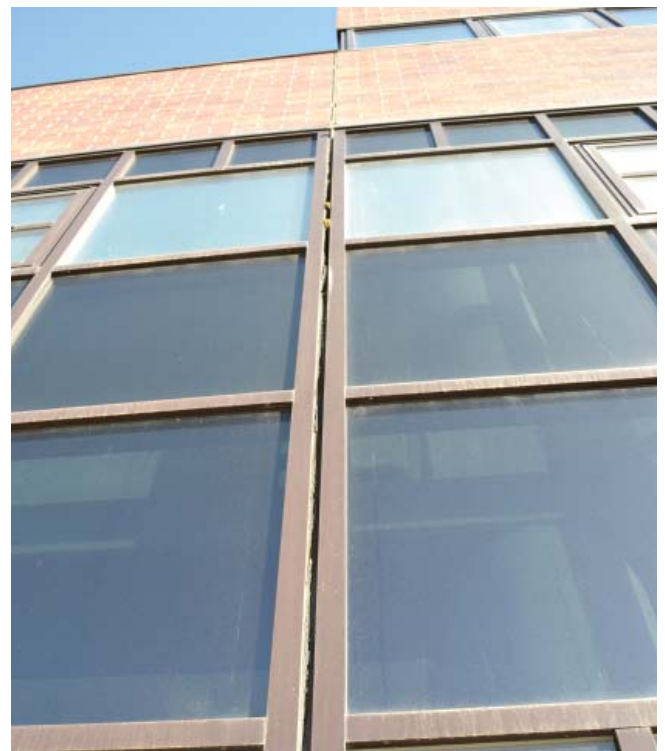
Failing window seal.

- **Exterior Envelope** - There is evidence throughout the exterior of the building of failing window seals, cracking columns and heaving concrete. Joint sealant has become cracked and/or eroded, both along the perimeter at grade and within vertical control joints. In addition, some or all of the exterior doors do not meet the current five pound pull limit stipulated by ADA.

Areas where joint sealant has become cracked or eroded, both along the perimeter at grade and vertical control joints, will be re-sealed. Where required, doors will be replaced to meet ADA standards. Windows where the seals have failed will be replaced or, if possible, repaired.

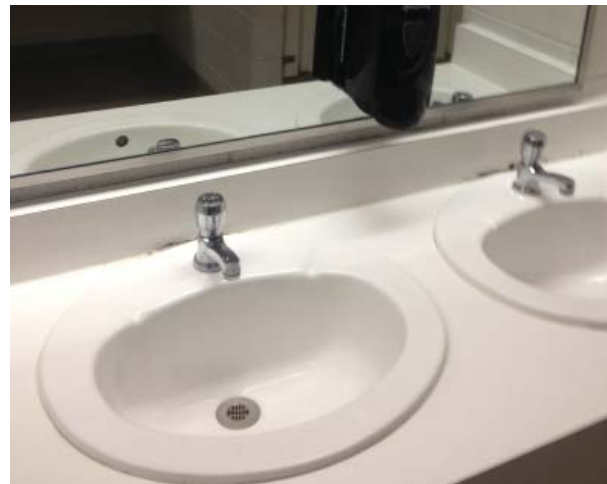
Original North Classroom bathroom fixtures.

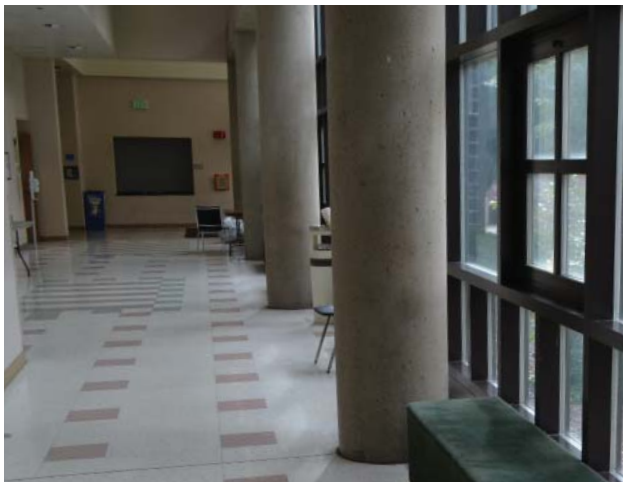
North Classroom corridor - no updates since 1987.

All of the corridor areas shown on the graphic will receive new paint, base and ceiling tile. These items will be coordinated with any lighting improvements that will be taking place as part of the building system improvements. Most of the corridor areas are terrazzo flooring, and will remain and be re-finished. Any corridors areas that contain other types of flooring (carpet, tile) will be replaced with new materials. The corridor area is a total of 38,465 square feet.

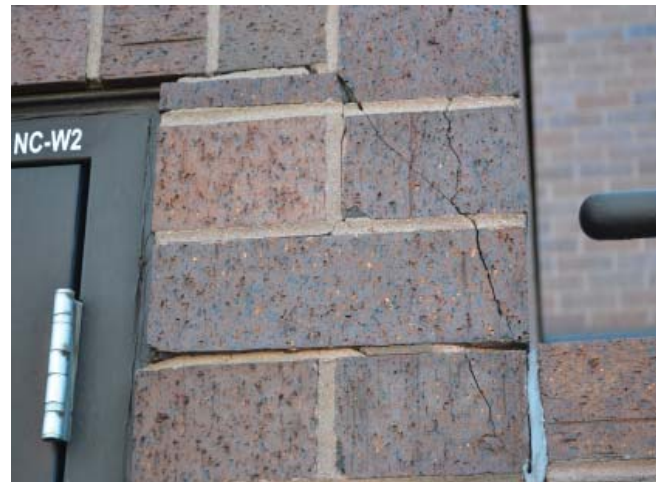
Exterior cracking around door.

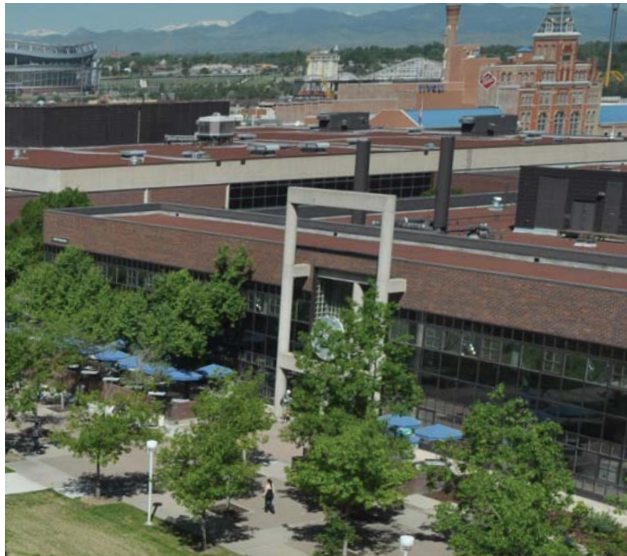
Existing North Classroom roof.

exterior soffits. The 2013 FCI reported that the roof drain is now problematic as well. The roof is 23 years old. It is one of the areas of greatest concern.

The roof will be replaced. The total square footage of the roof is 97,466.

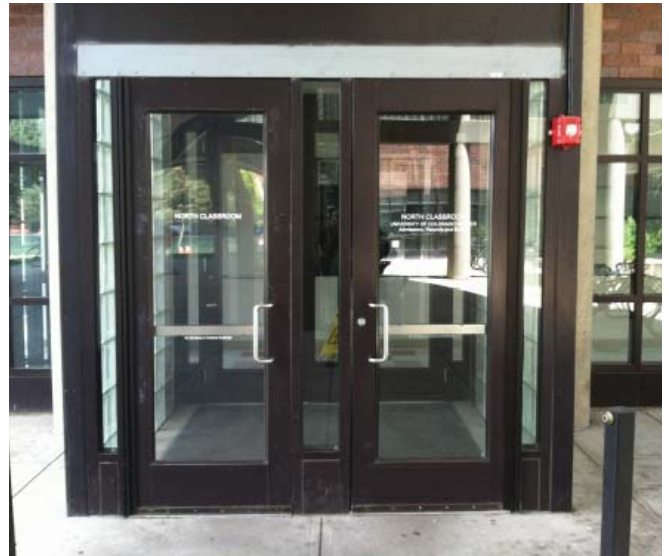
Exterior doors that require ADA upgrades.

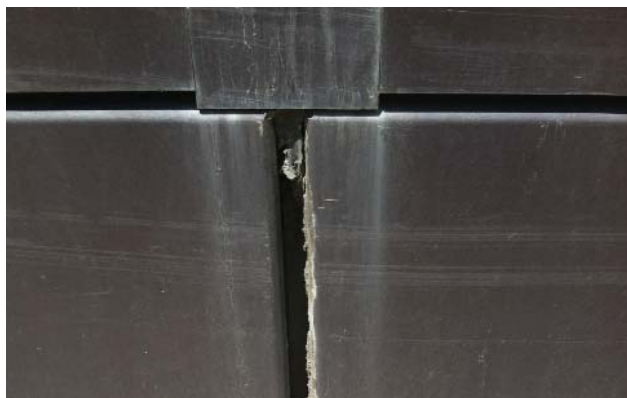
Failing exterior sealant.

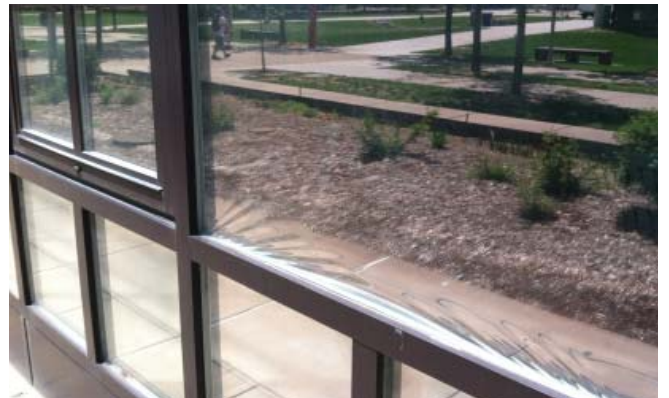
Warped window film.

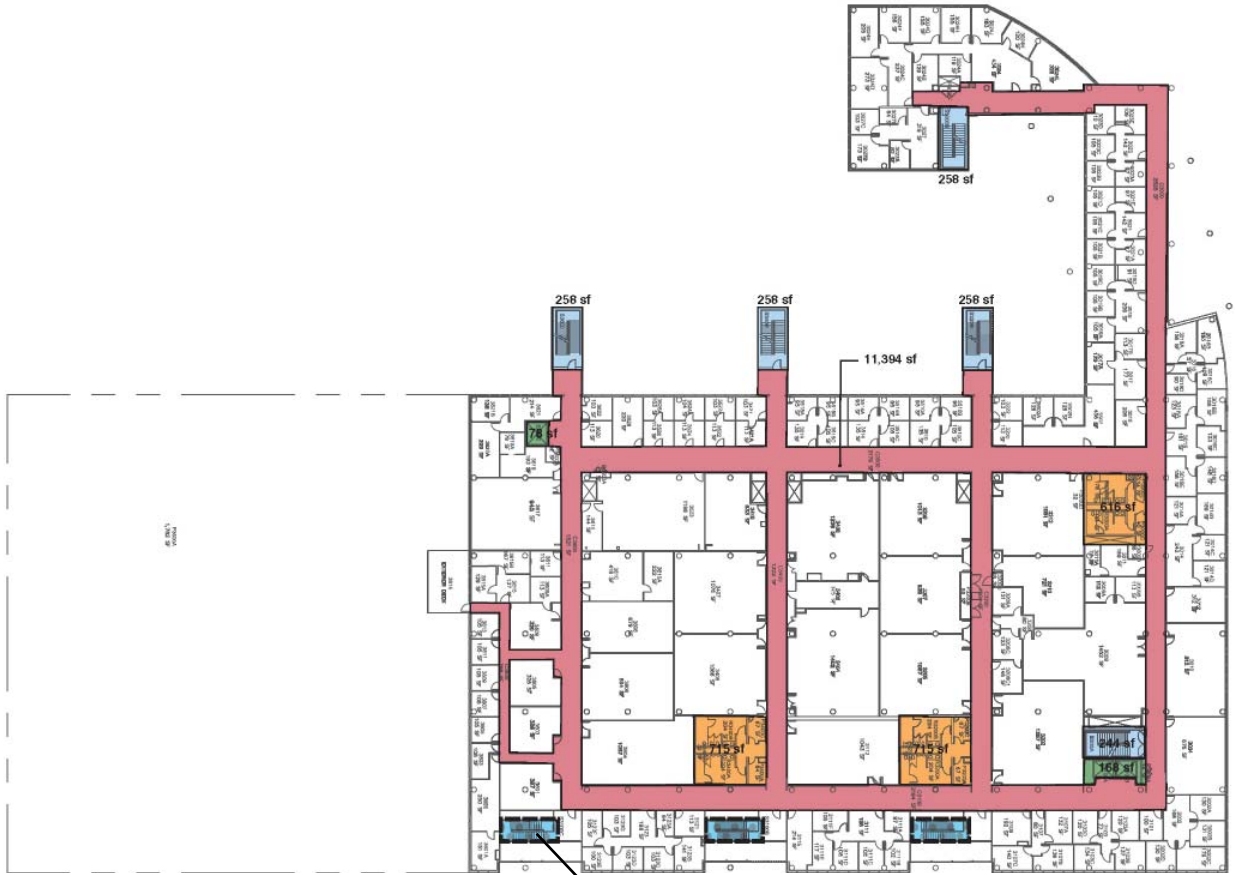
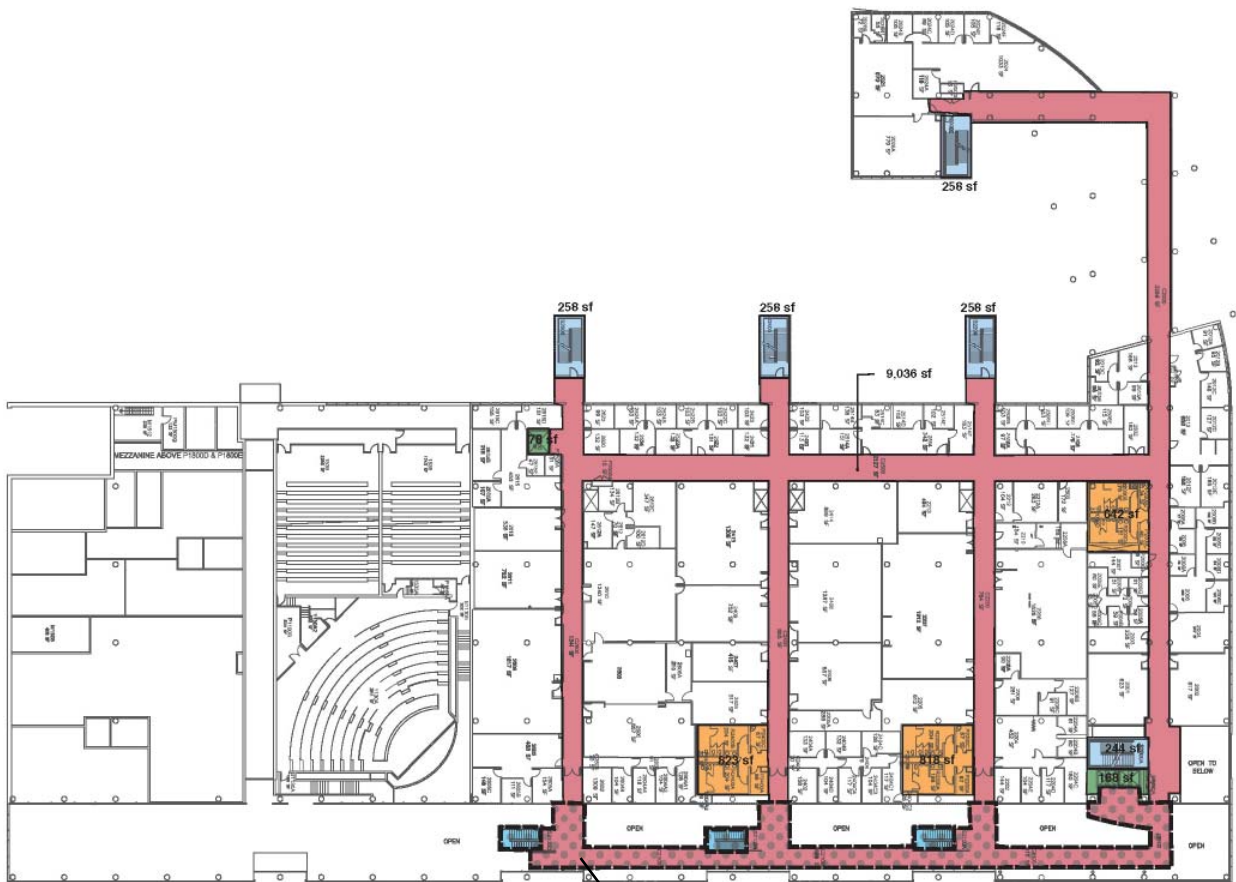
**Amended Program Plan Improvements Legend**

- Corridors
- Restrooms
- Elevators
- Stairwells
- Corridors part of Academic Building 1 Backfill or Original Program Plan and Student Funded Project
- Stairwells Part of Original Program Plan and Student Funded Project

There are eight stairwells in the North Classroom. However, three of them lie in the atrium area, and will be covered in the atrium renovation that was part of the original North Classroom Renovation program plan. This amended program plan adds improvements to the remaining five stairwells. Of these five, two of them serve all floors of the building. The remaining three, which lie in external, non-conditioned towers, terminate on the third floor. The stairwell improvements will be primarily paint (on handrails and vertical and horizontal walls), ceiling tiles (where applicable) and re-finishing or finishing stair treads.

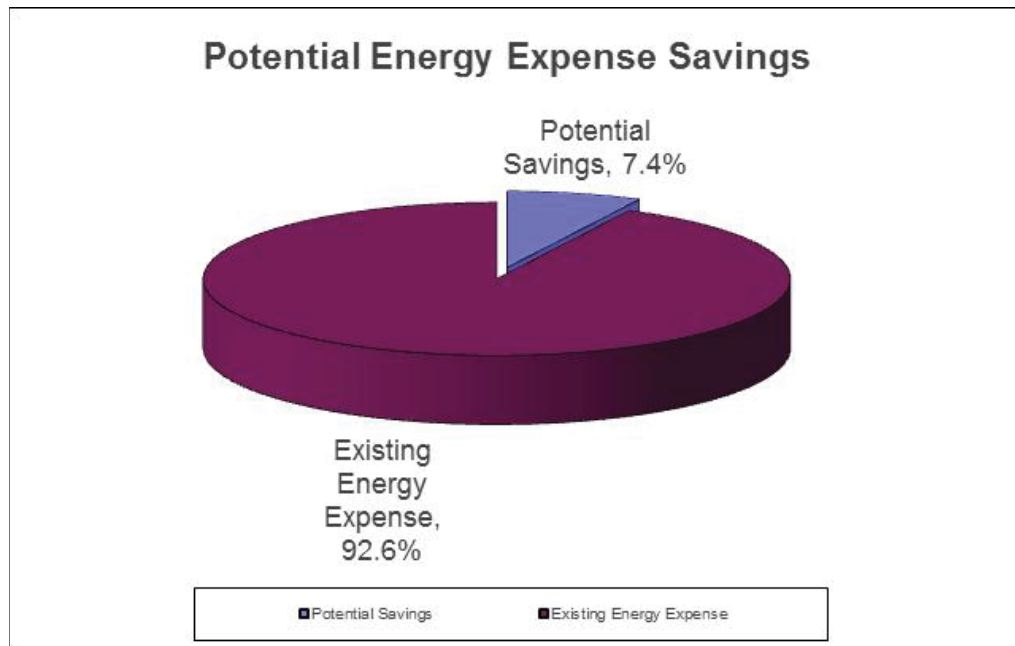
The following chart shows the potential percentage of this facility's annual energy expense that could be saved by implementing all of the Energy Conservation Opportunities recommended in this report. There was no steam billing data provided; therefore the steam portion of the building's energy use was estimated.

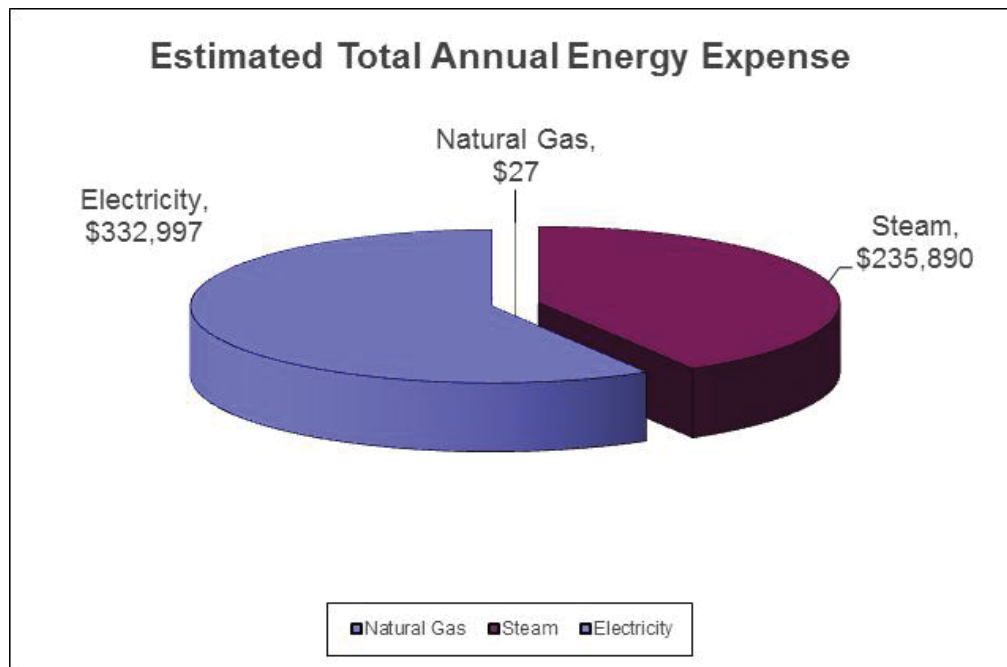
One Year of Electricity Consumption – July 2010 - May 2011

This building's electric and gas meters serve seven buildings and use sub-meters to determine each building's usage. This data is not as accurate as a primary meter and there were several instances where data was missing and estimates had to be made. There was no cost provided, so the cost was estimated using the building's rate structure. All electrical, gas and steam usage data is estimated based off Xcel Energy's rate structures.
